# **A lake dammed by a human-induced landslide**

Lake Arló in Hungary

Gábor Gercsák, Budapest, Hungary  
Eötvös Loránd University

**June 2016**

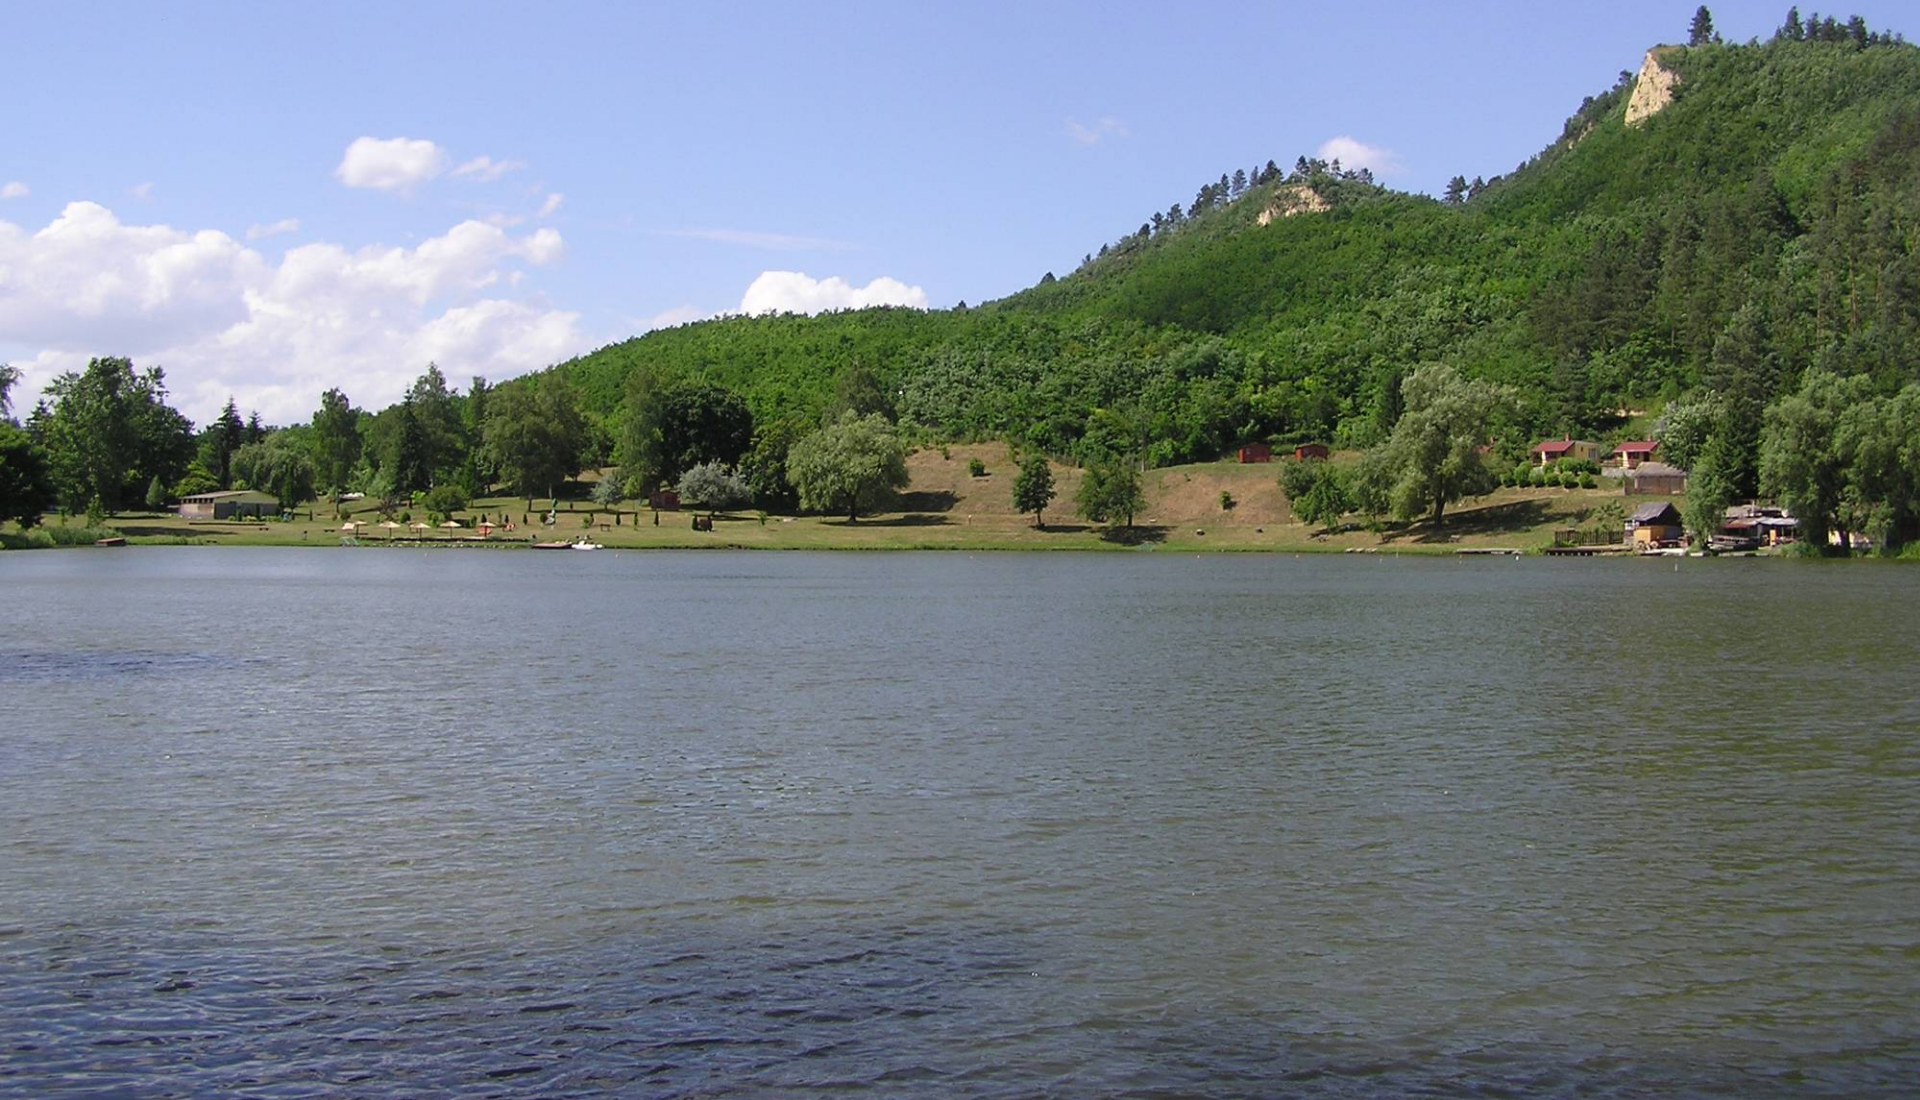
# Aerial photograph of Lake Arló

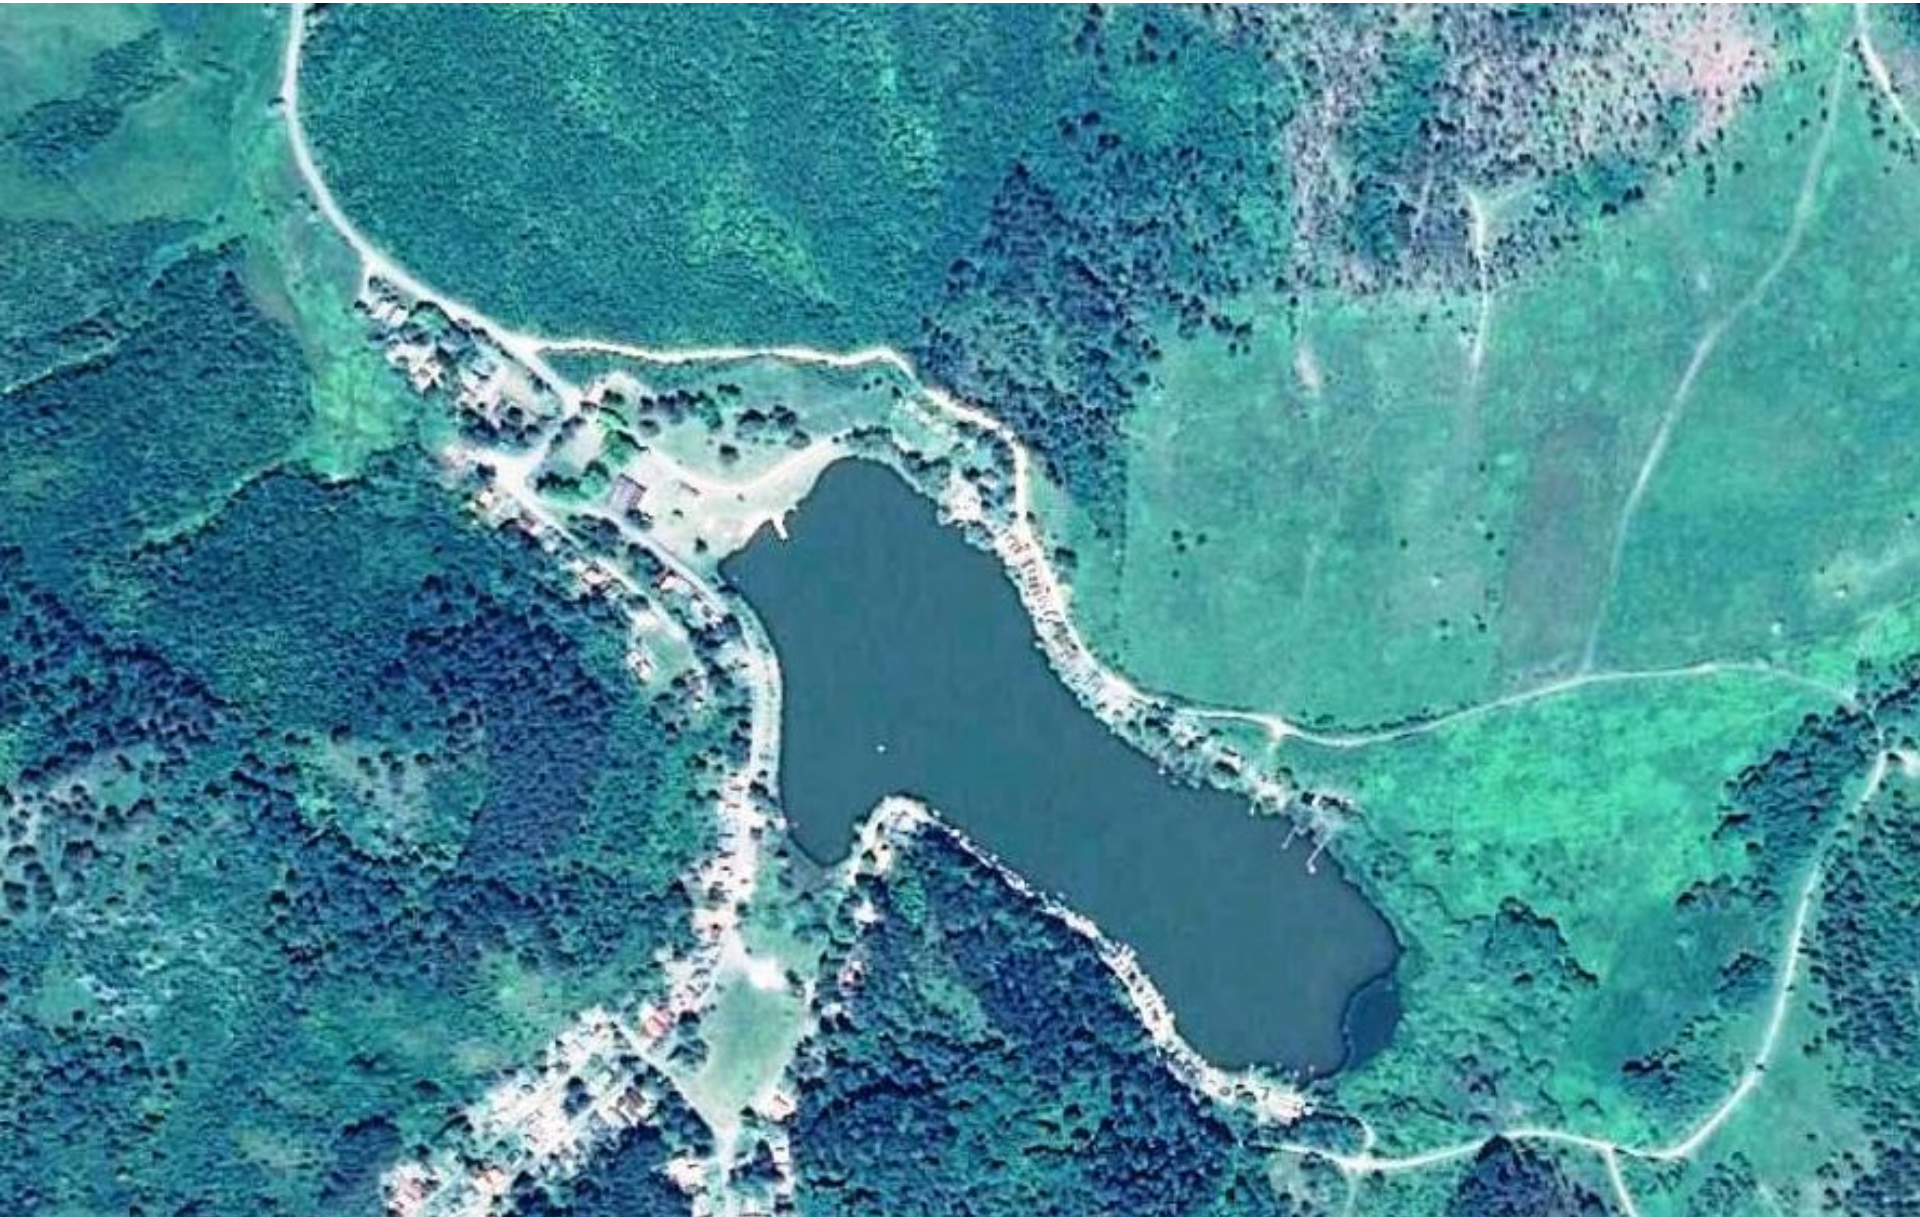
# Third military survey (late 19th c.)

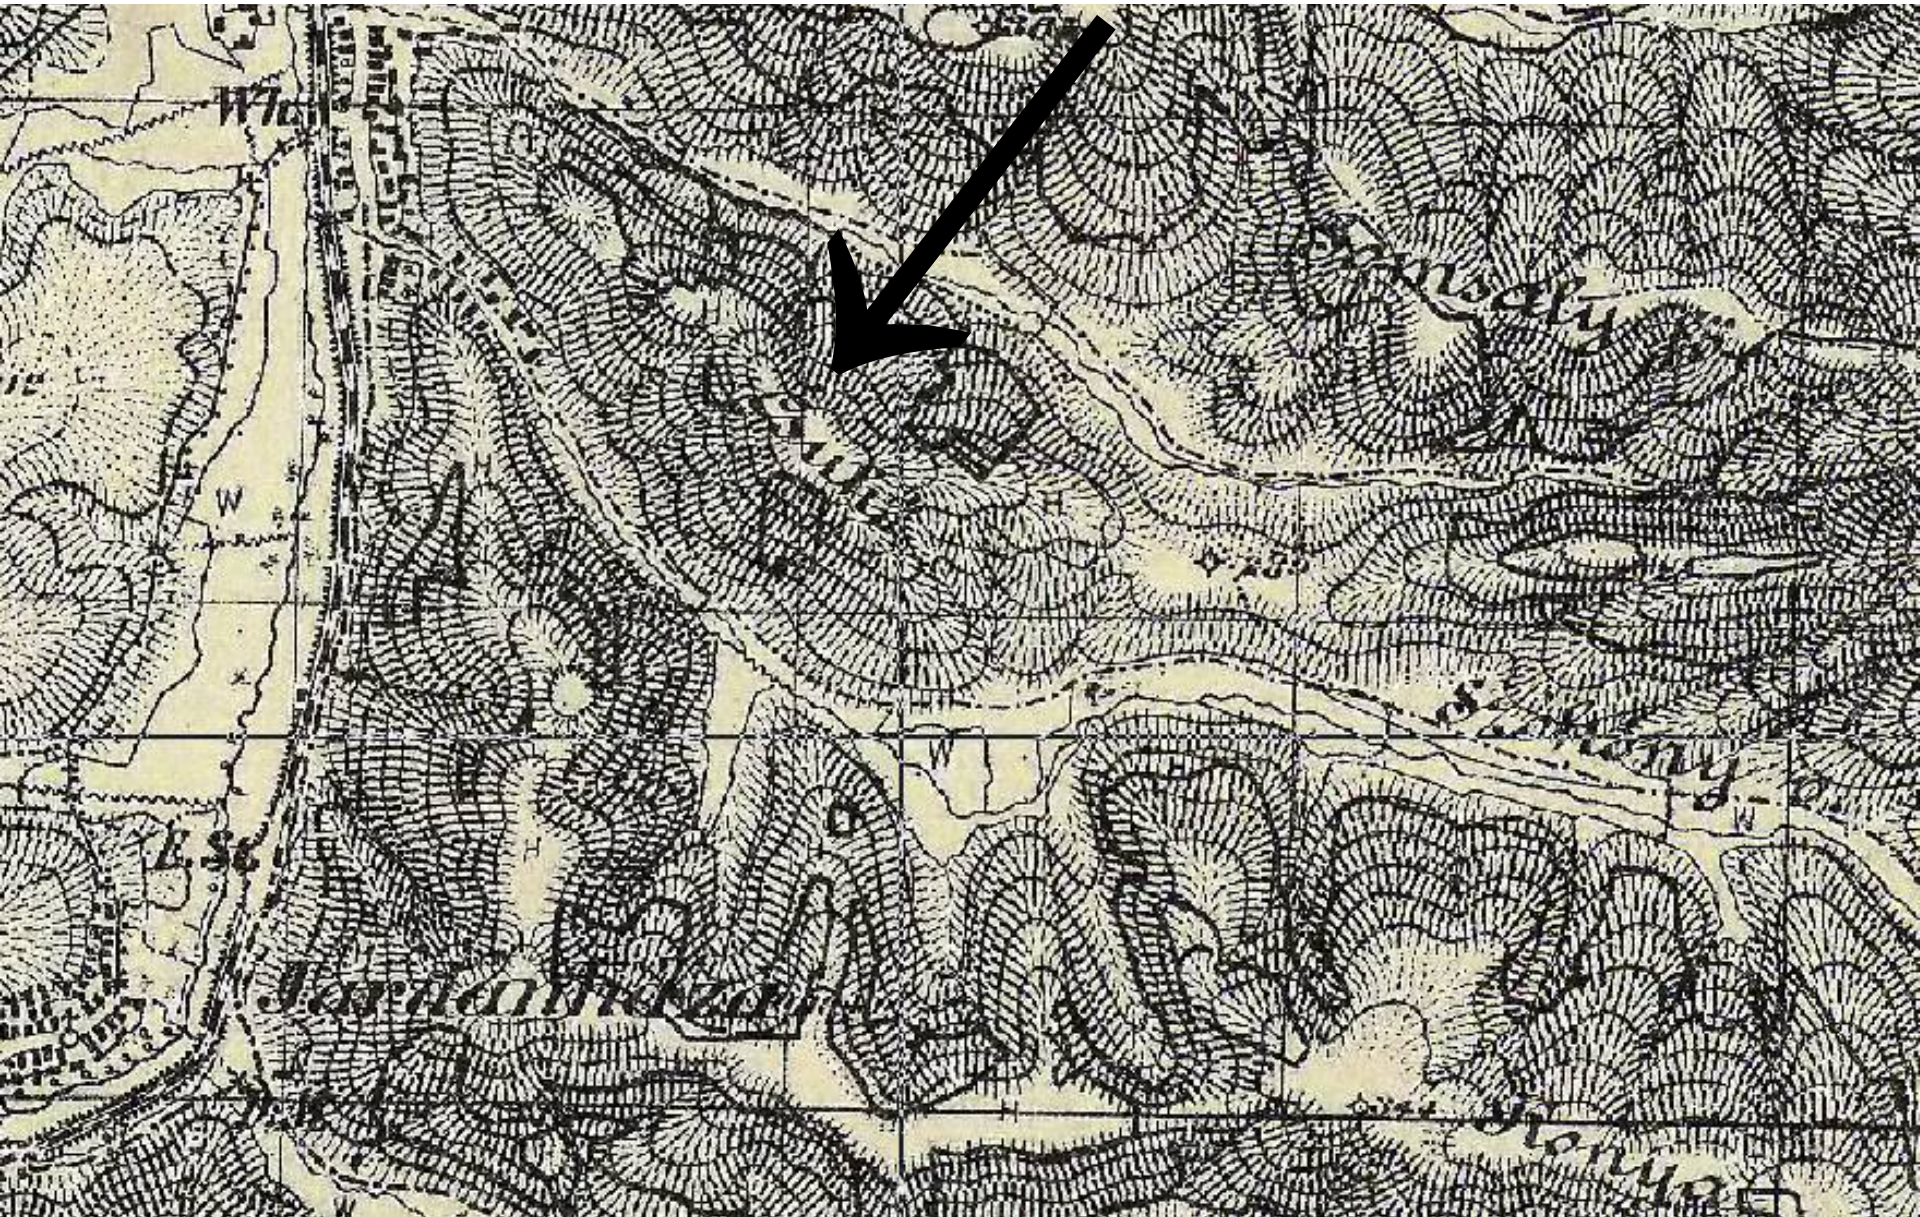
# Start of the failure in 1863

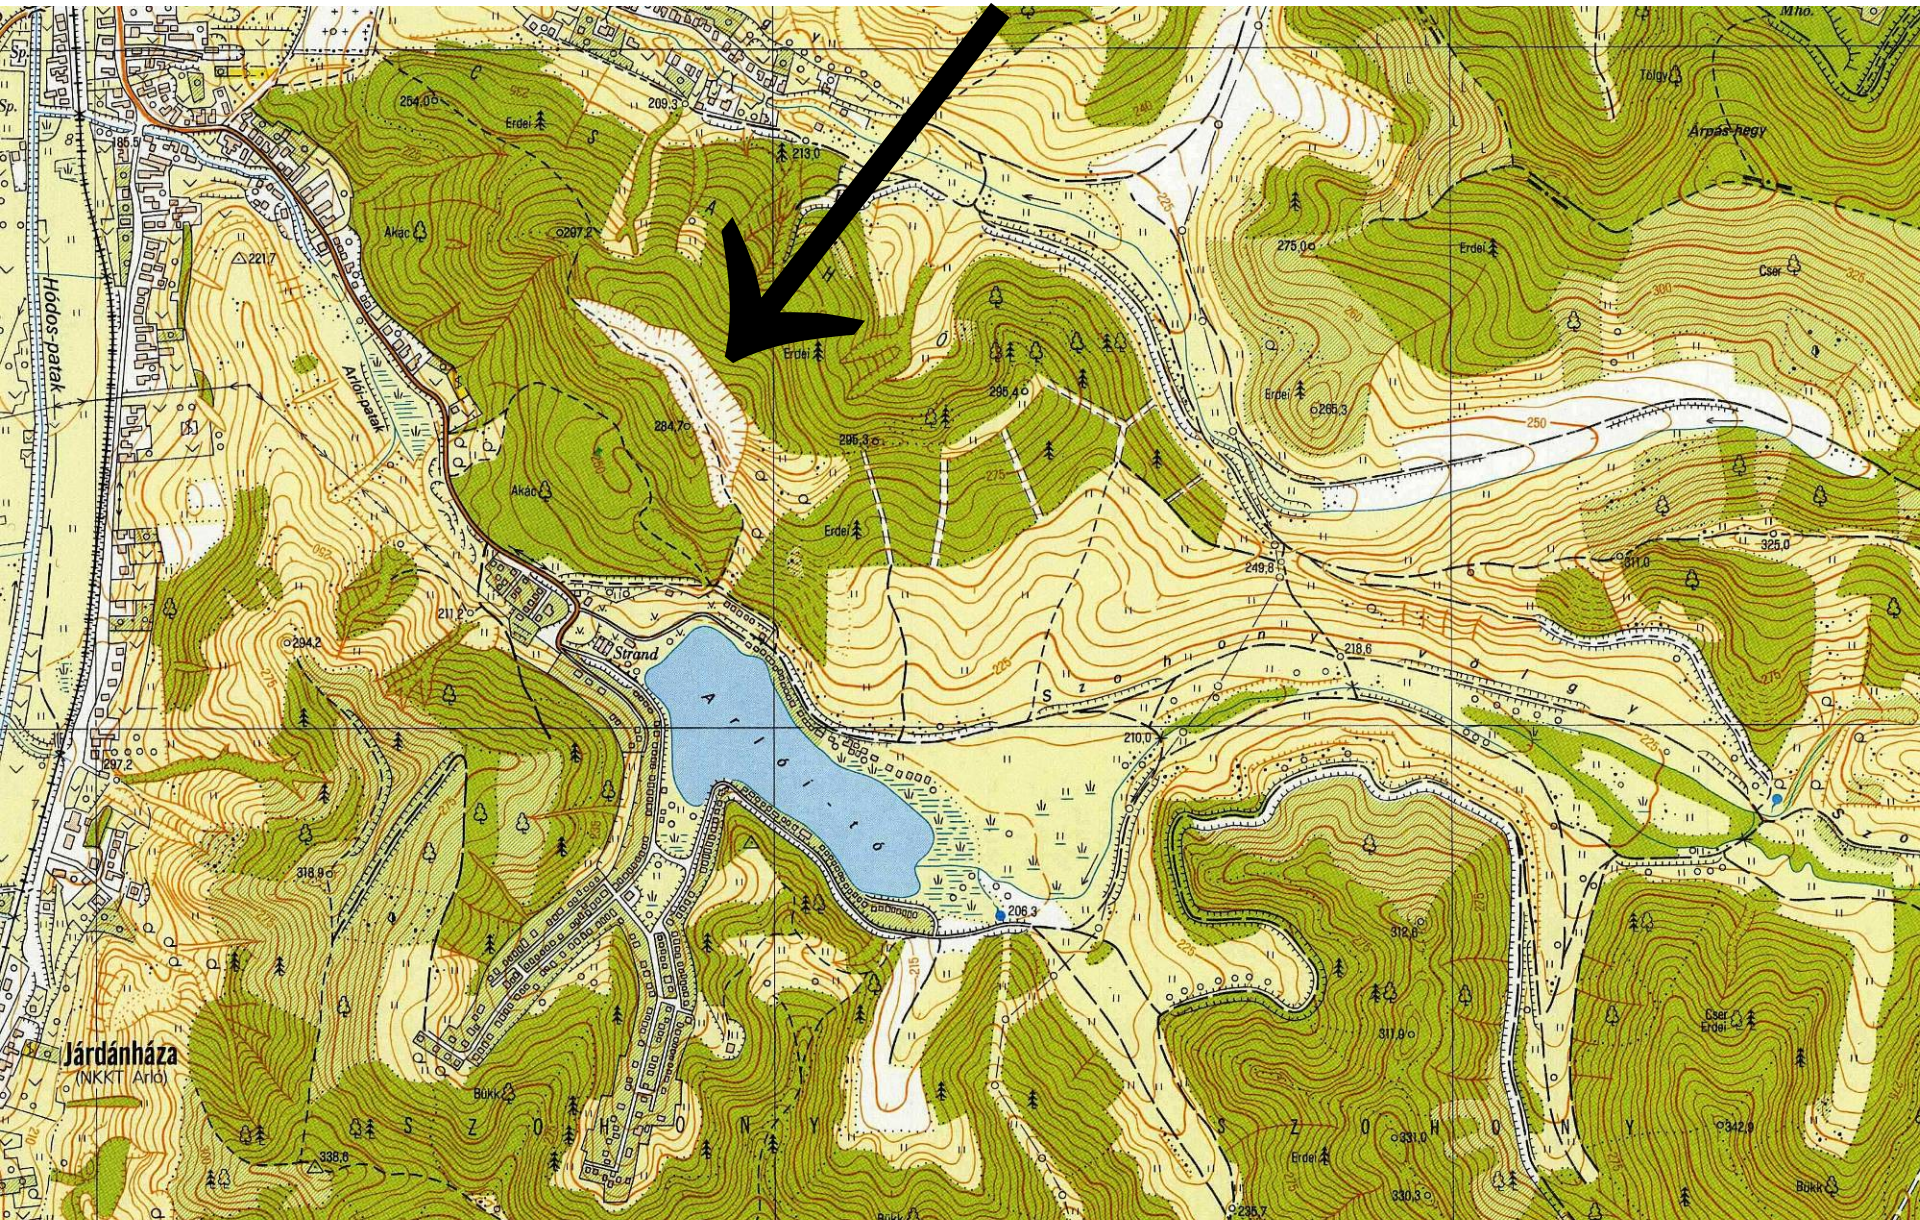
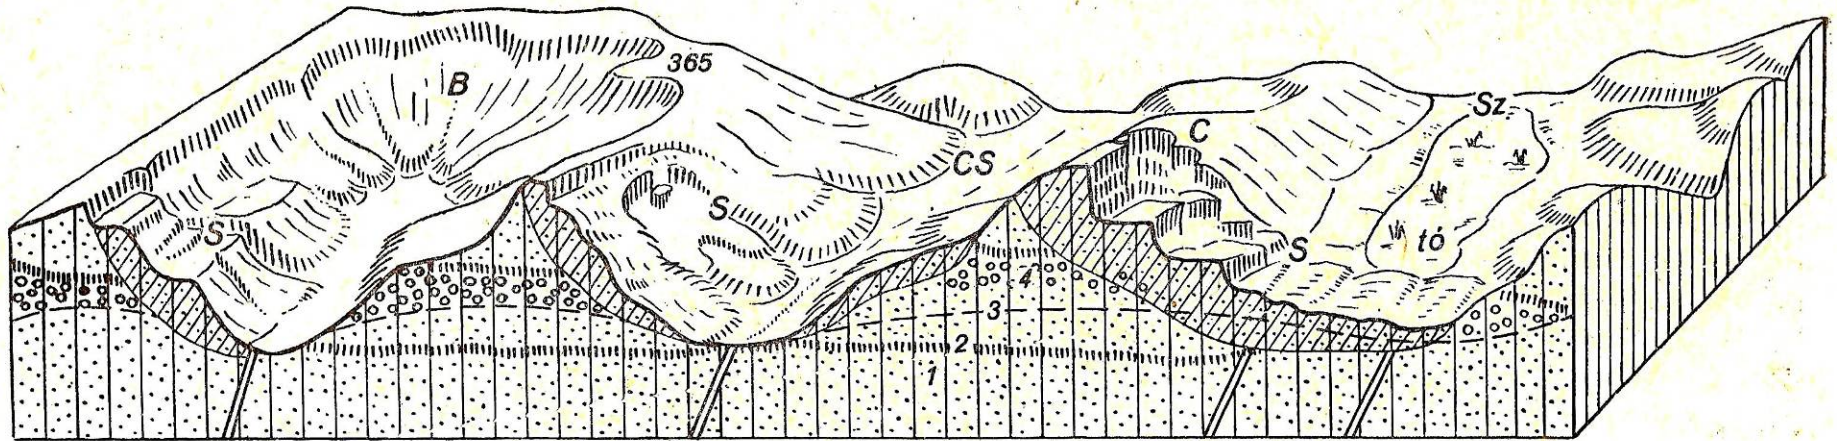
# Block diagram of the area

B = Benéte Valley

C = Csahó Hill

Cs = Csahó Valley

S = Landslides

Sz = Szohony Valley

tó = Lake

1 Lower Miocene

2 Coal seam

3 Water table

4 Loose pebbles under  
the upper coal seam

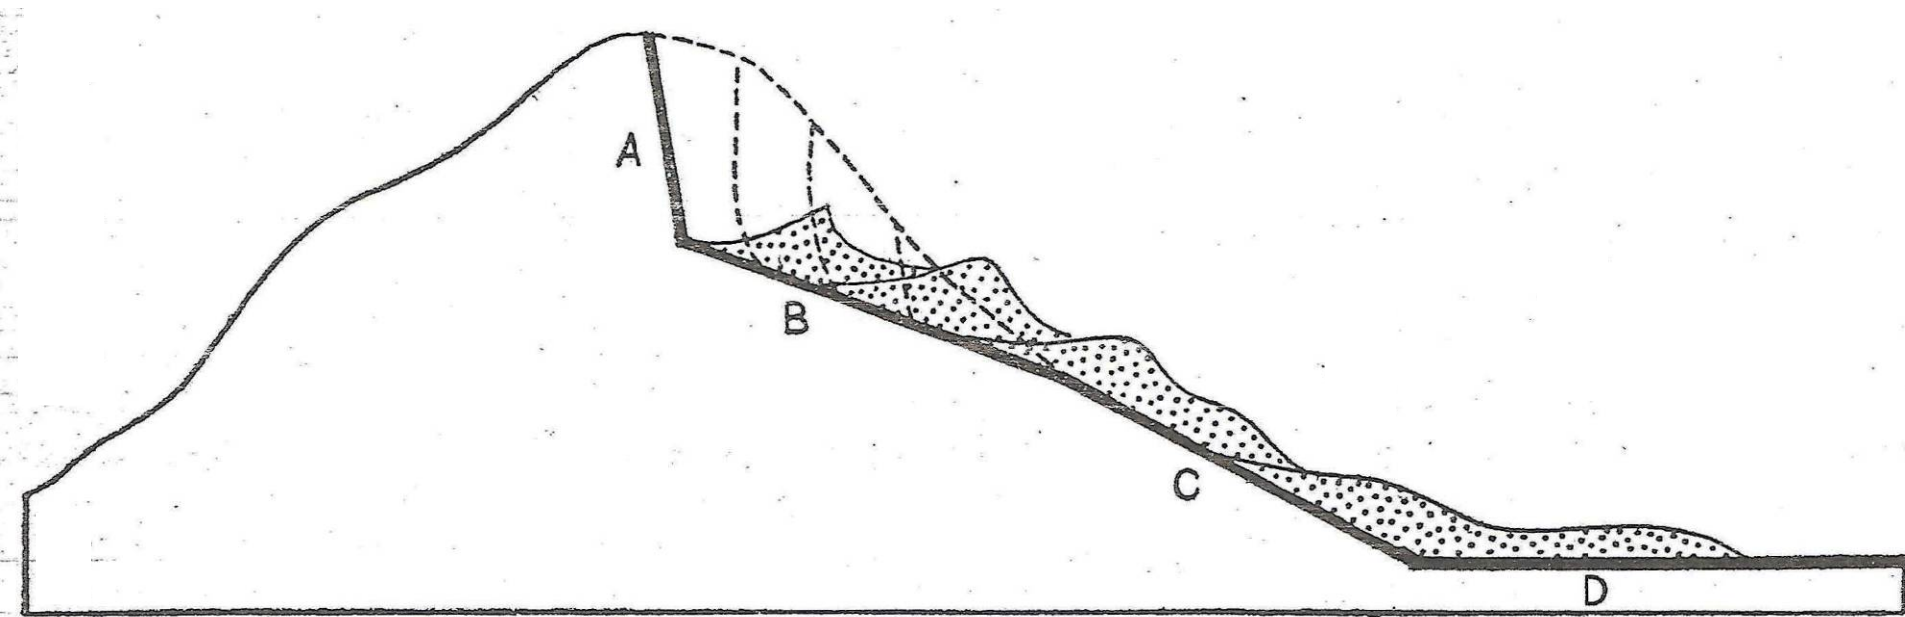
# Cross-section of the slide path

Bottom to top = 145 m

A = Fall line

B = Slide path after the landslide

C = Original plane of the slope

D = Original valley bottom (193 m)

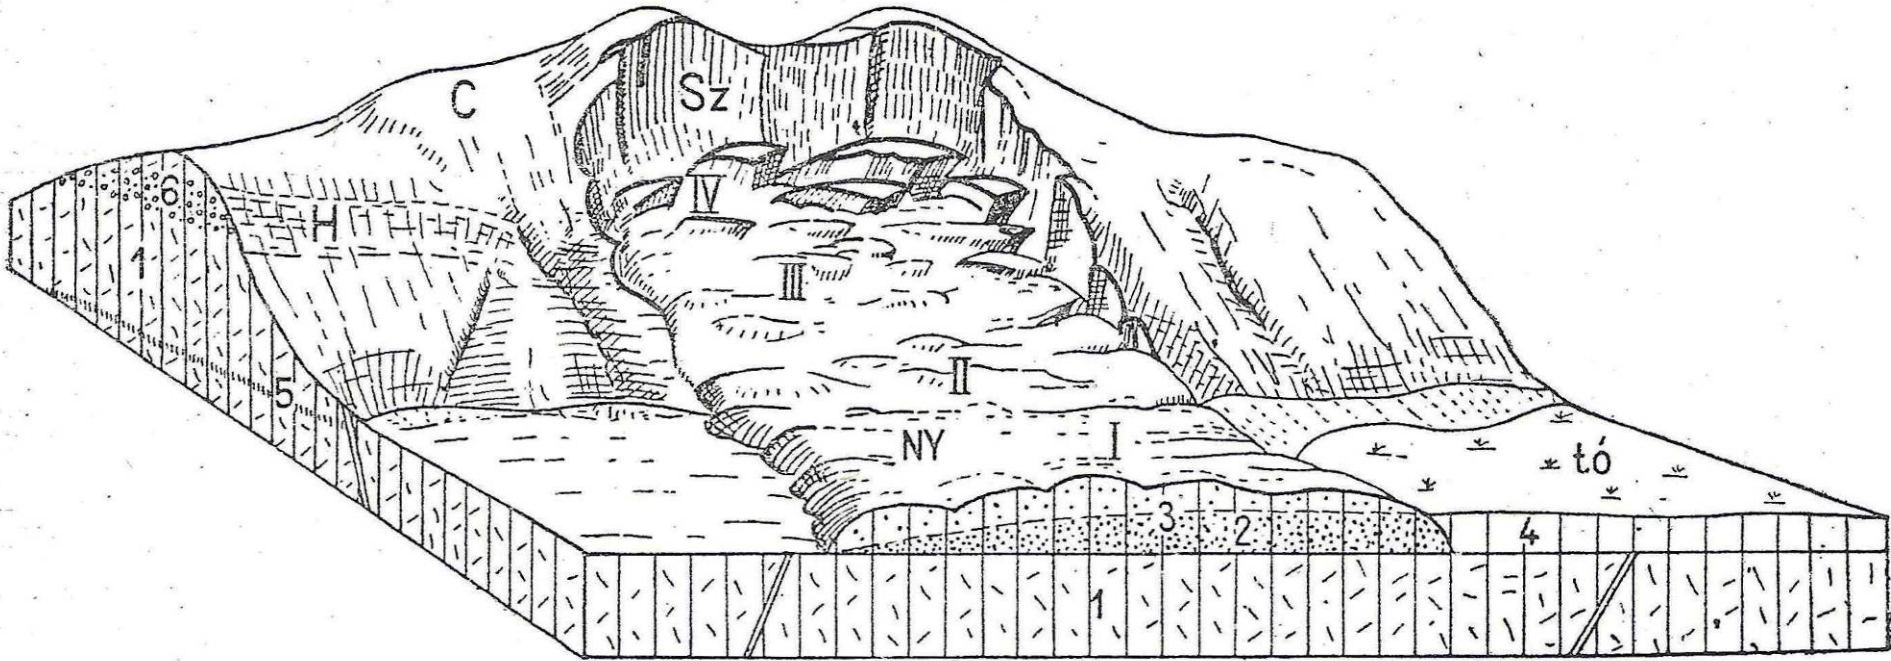
# Block diagram of the slide

C = Csahó Hill

Sz = Rock wall

Ny = Tongue

H = Pebbles

I-IV = Belts of the slide

1 = Miocene base rocks

2 = Saturated layer

3 = Level of water table

4 = Lakewater

5 = Lower coal level

6 = Pebbles

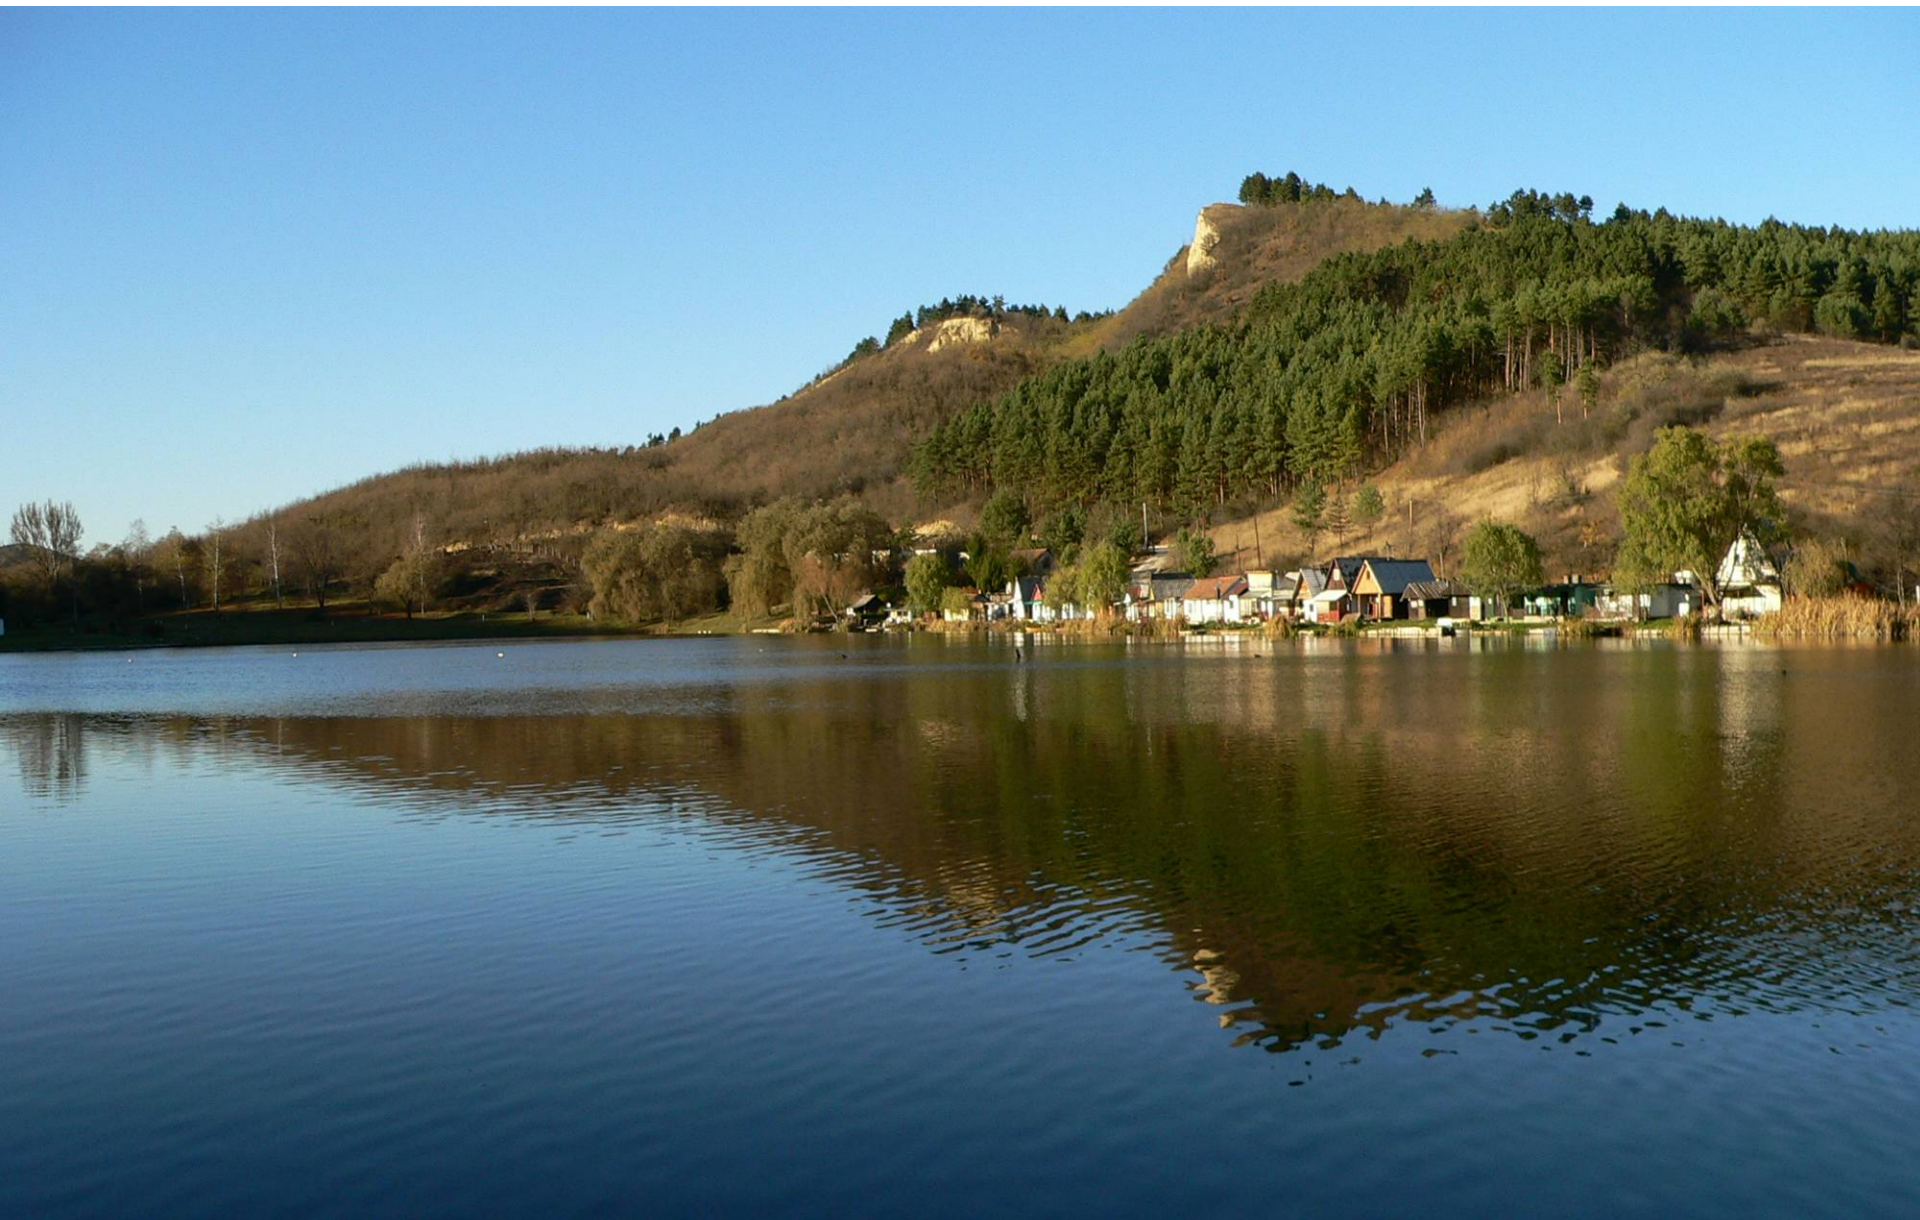
# The slid hillside
