# GEOGRAPHICAL CHARACTERISTICS OF EARTHQUAKES IN THE SOČA RIVER REGION

## GEOGRAFSKE ZNAČILNOSTI POTRESOV V POSOCJU

Milan Orožen Adamič  
Mauro Hrvatin

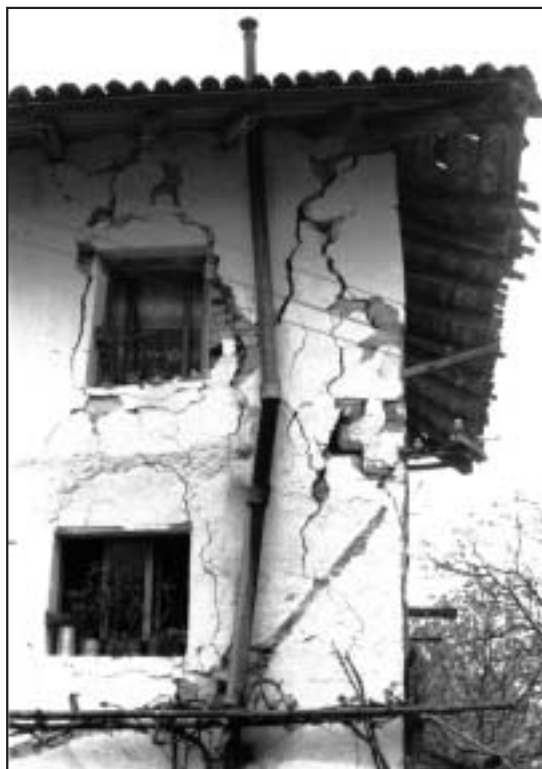
Figure 3: After the first strong earthquake shocks on May 6, 1976, numerous buildings in the upper Soča region were heavily damaged. The photograph shows an example of damage to a typical, traditionally-built house in Podbela, which at the beginning of the earthquake activity was already the most damaged settlement. The picture was taken on May 7<sup>th</sup> when the first series of earthquakes had not yet ended. This building was later demolished because repair was no longer economically justifiable (photography Milan Orožen Adamič).

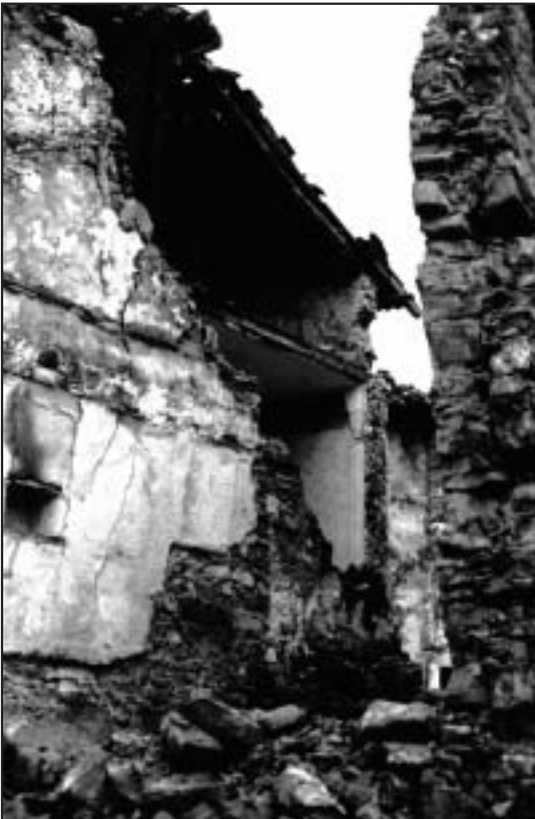
Figure 4. This photograph from Podbela clearly shows how the wall of a house was built. The rocks are arranged so that the wall is flat on the outside and the inside and held together with limestone mortar and plaster. This traditional method of building is very poor from the construction point of view and the consequences were therefore catastrophic (photography Milan Orožen Adamič).

The majority of the older rural residential and farm buildings in Slovenia are built of stone with lime mortar. The quality of construction is usually poorer than in the more important urban buildings. Walls are usually constructed of two layers of uncut or partly cut stone with the space between filled with stone gravel mixed with poor lime mortar. The majority of the houses were built in this fashion in the Kozjansko region where the 1974 earthquake caused considerable damage. Following the 1976 earthquake in the upper Soča region, when many old buildings had to be demolished or repaired, houses built before 1945 were relatively few (1,919 or 32.6%). In the Tolmin region, there were few homes built in the period between 1945 and 1970, only 19.3%, as there was a low rate of construction in that period. The proportion of homes built after 1970, which is the consequence of restoring housing after the 1976 earthquake, is well above the average (44.7%).

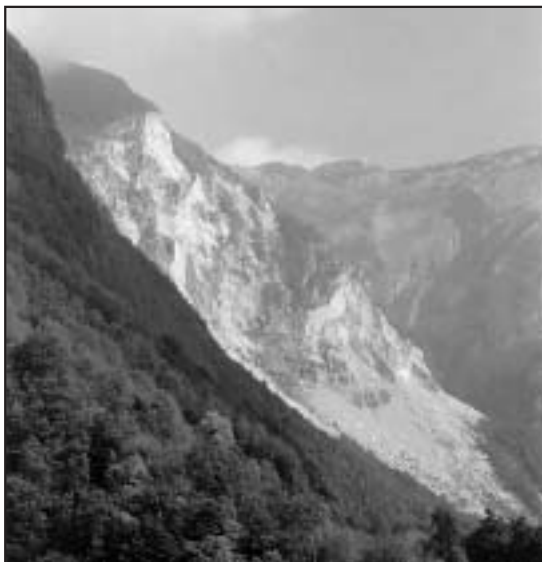
Figure 8. Rockfalls in the area of the Tolminka watershed greatly changed the previous appearance of the landscape. The asymmetrical form of the slopes on both sides of the valley is even more pronounced (photography Borut Peršolja).

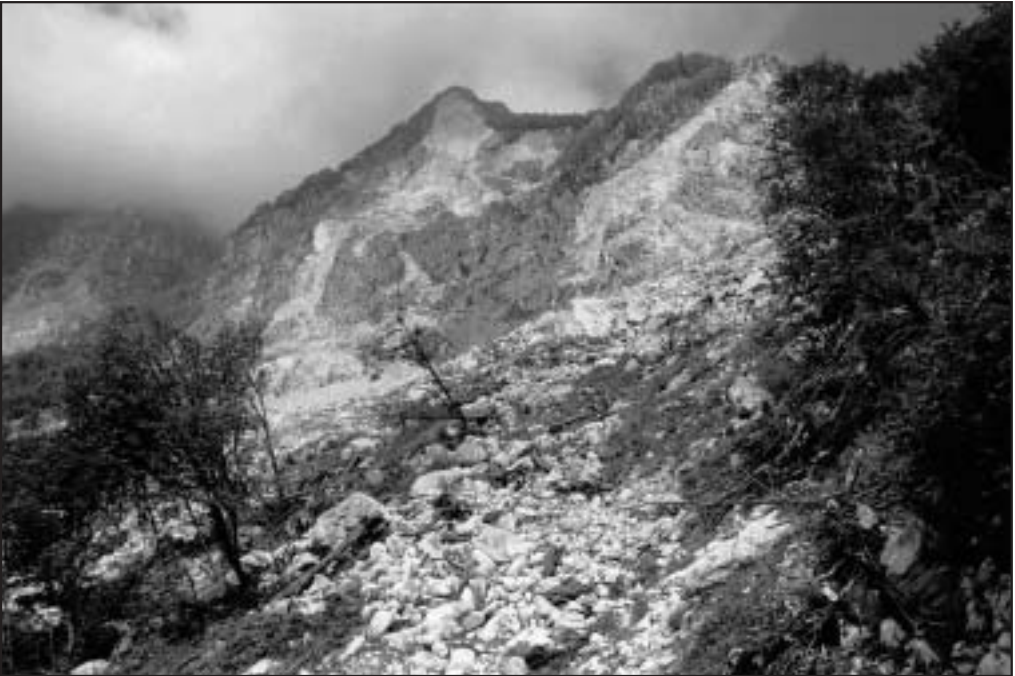
Figure 9: The rockfalls from the wall of Mount Osojnica were surprising due to the size of the breaks in the wall and the quantity of rubble that greatly transformed the previously forested slopes. On the site of the rubble, the forest was stripped bare and tongues of larger rocks forced their way toward the Tolminka River (photography Borut Peršolja).
