SUMMER STORMS IN SLOVENIA IN 1994 (SURVEY, BASIC CHARACTERISTICS, AND DETAILED ACCOUNTS OF SELECTED CASES)

Miha Pavšek

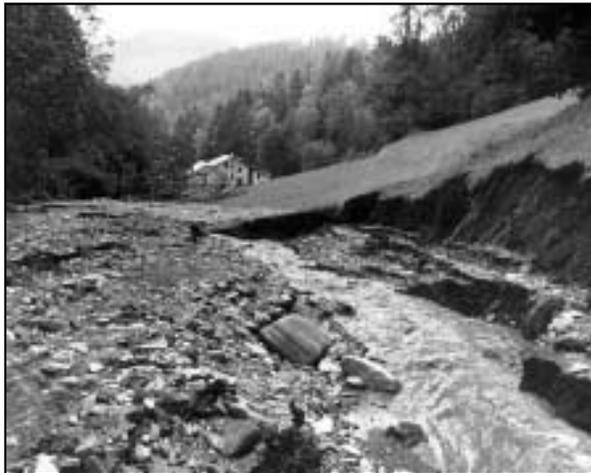
In the upper course of the Kotredeščica (The Sava Valley region) nearly the entirely narrow valley bottom was flooded (photography M. Pavšek).

V zgornjem toku Kotredeščice, nad Zagorjem ob Savi je, bilo poplavljeno dolinsko dno po vsej širini zasuto s plastmi hudourniških nanosov (fotografija M. Pavšek).

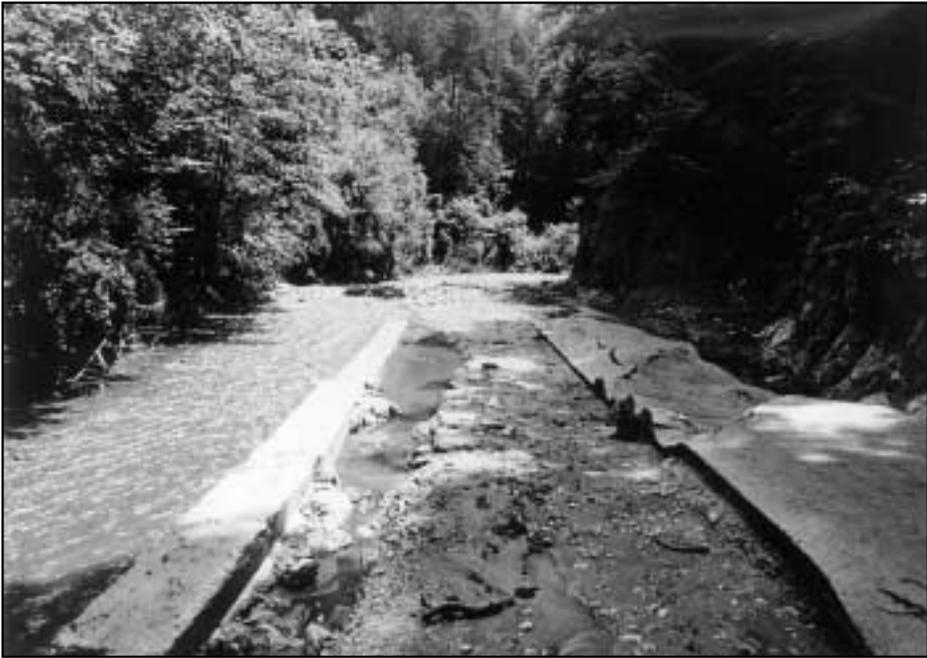
Figure 6: A completely destroyed section of road in the Kotredeščica catchment area. Here the valley narrows completely in limestone, and therefore the power of the water was even greater. The only thing that was remained was a buttress while almost the entire asphalt surface was carried away.

Slika 6: Popolnoma uničen del ceste v povirju Kotredeščice (Tesen). Tu se v apnencu dolina povsem zoži, zato je bila moč vode še večja. Ostal je le oporni zid medtem ko je skoraj v celoti odneslo asfaltno prevleko.

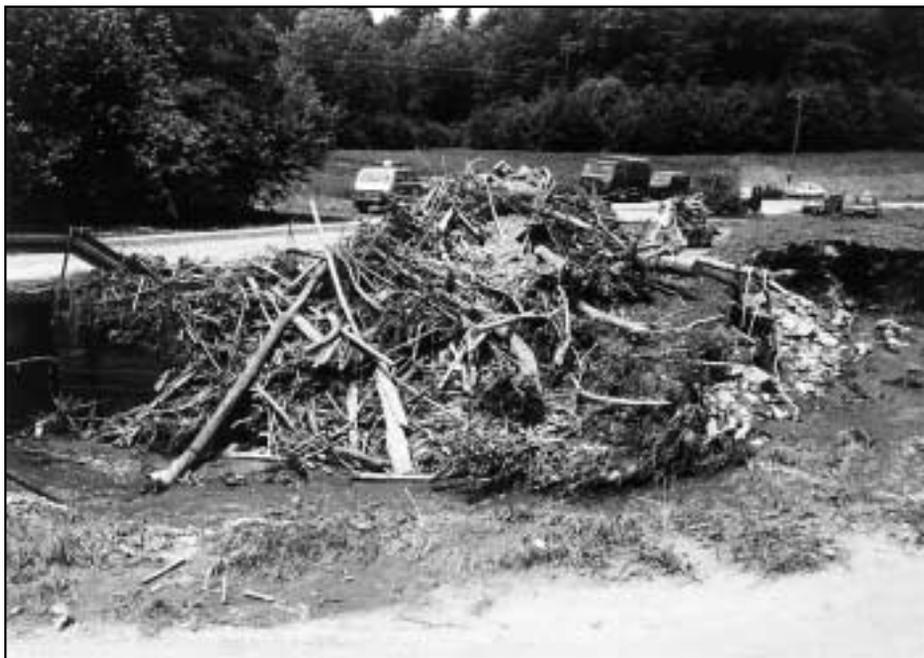
Figure 7: Bridge in one of the settlements on the upper course of the Kotredeščica. Torrential alluvium soon blocked the inadequate outlet, and water flooded all the lower lying part of the settlement.

Slika 7: Most v enem od zaselkov v zgornjem toku Kotredeščice. Premajhen prepust so hudourniške naplavine kmalu zamašile, zato je voda poplavlila ves nižjeležeči del zaselka.

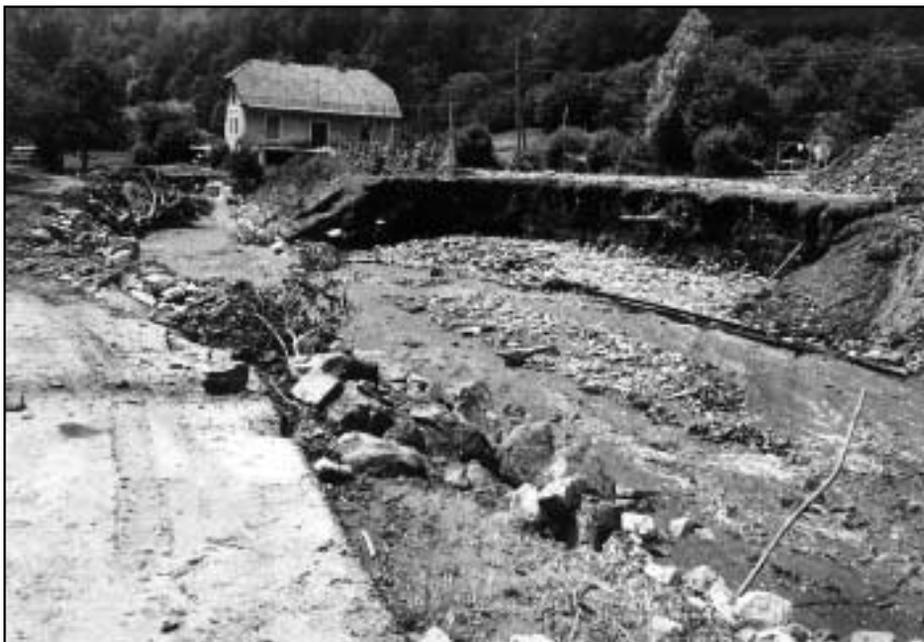
Figure 8: In some places the erosive indentations in the banks along the Kotredeščica were so extensive that they exposed water distribution pipes (on the right).

Slika 8: Erozijske zajede v brežine ob Kotredeščici so imele ponekod tako velik obseg, da so razgalile vodovodno napeljavo (na desni).

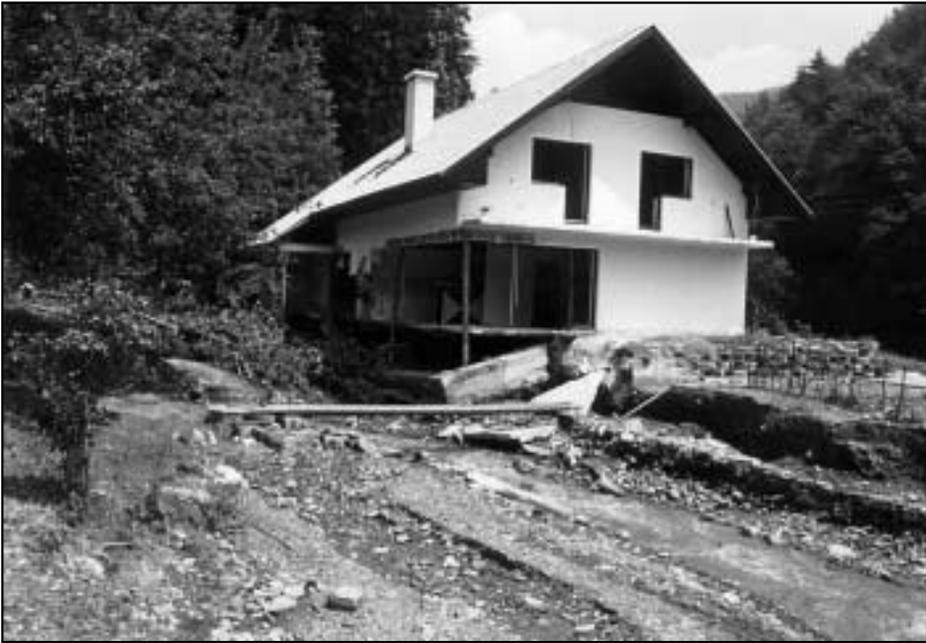
Figure 9: The torrential Prešnik tributary undercut the foundation of a newly built house directly beside the riverbed. In the catchment area of the Kotredeščica, none of the older houses stand so near the streams.
 Slika 9: Hudourniški pritok Prešnik je povsem spodjedel temelje pred kratkim zgrajene stanovanjske hiše. Zgradili so jo na neprimerni lokaciji neposredno ob strugi. V povirnih delih Kotredeščice ni starejših hiš, ki bi stale tako blizu potokov.

In one settlement, a torrential tributary undercut the foundation of a newly built house (Figure 9). It stood right on the outer side of the stream bed before the confluence with the Kotredeščica at the outlet of a side ravine into the gentler main valley with a relatively wide bottom. The foundations

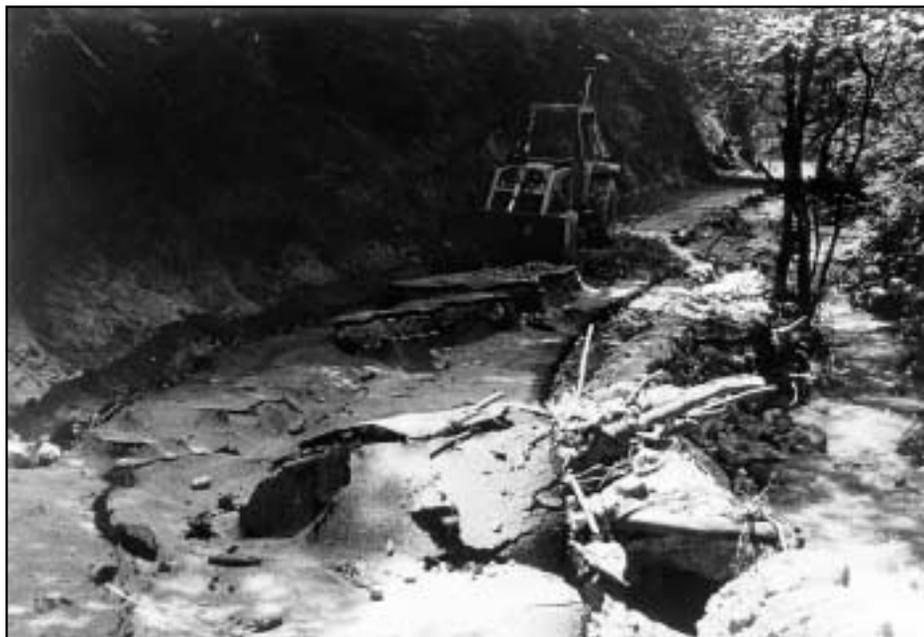
Figure 10: One local road had been paved with asphalt only a few weeks before the storm. In the narrow ravine, the stream and its torrential tributaries cut into the road and completely destroyed it. From the size of the rock debris deposited along the edge of the road, we can see the force of the water.

Slika 10: Eno od lokalnih cest so asfaltili le nekaj tednov pred neurjem. V ozki grapi so se potok in njegovi stranski hudourniški pritoki zajedli v cestno telo in ga povsem uničili. S kakšno silo je drla voda vidimo po velikosti kamninskega gradiva, odloženega ob robu ceste.

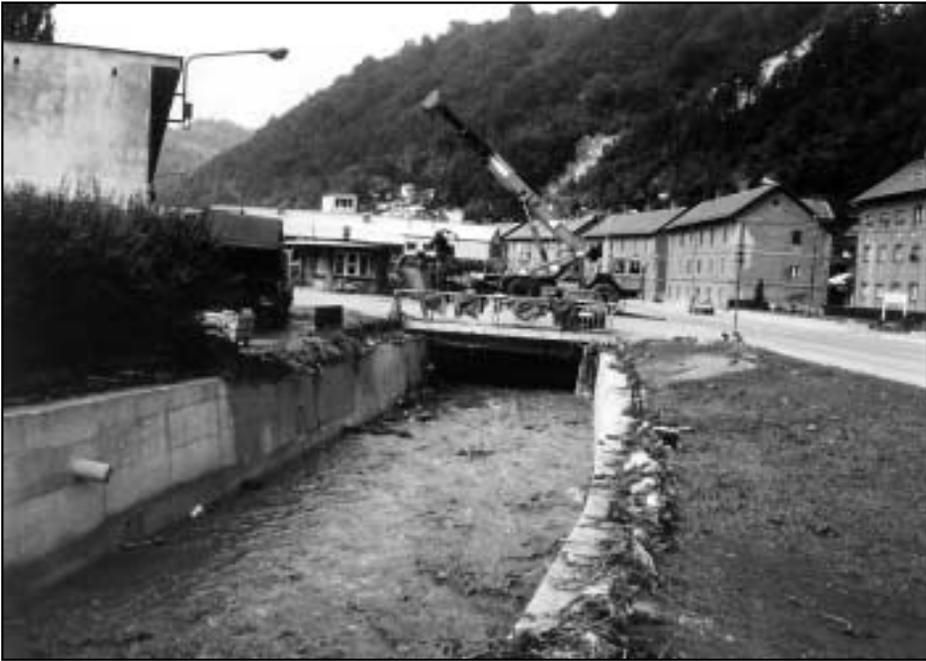
Figure 11: The industrial bridge near one of Trbovlje's factories is a typical example of not considering the natural laws of the fluctuation of streams, since the size of the outlet was greatly underestimated during its construction.

Slika 11: Industrijski most pri eni od trboveljskih tovarn je eden od tipičnih primerov neupoštevanja naravnih zakonitosti kolebanja vodotokov, saj je bila velikost prepusta ob gradnji močno podcenjena.

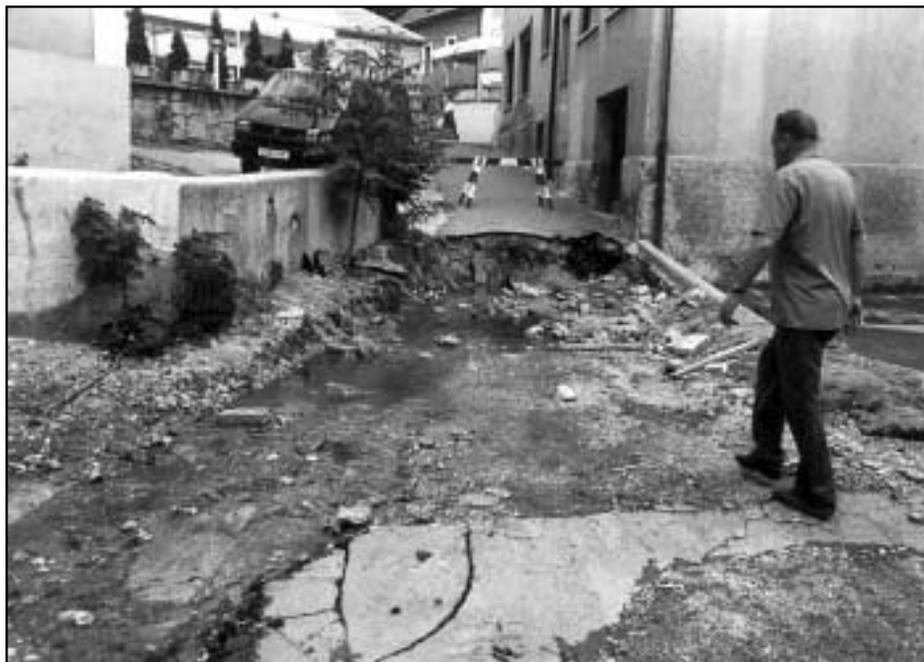
Figure 12: In the center of Trbovlje water came rushing from the mains and spread over the town streets. Part of the roadway was raised and carried away.

Slika 12: V osrednjem delu Trbovelj je pridrla na površje voda iz kanalizacije in se na široko razlila po mestnih ulicah. Pri tem je dvignilo in odneslo del cestišča.

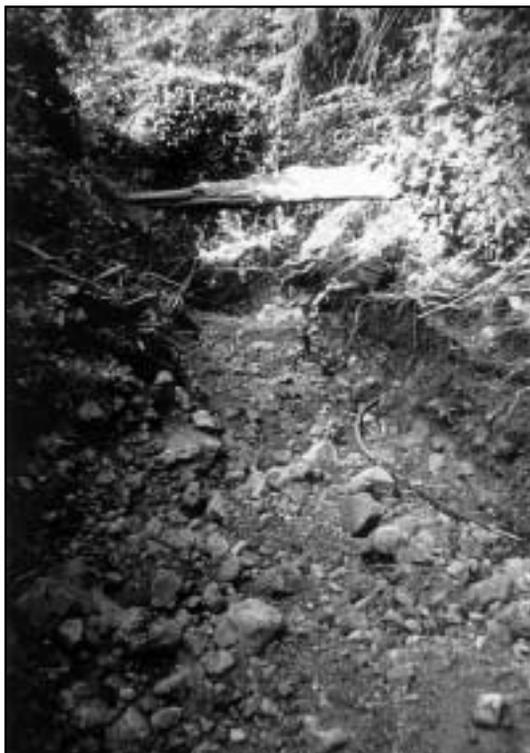
Figure 13: Traces of strong depth erosion at Hudi graben above Golnik. Almost in the direction of the greatest slope the route of a forest sledge route formerly used primarily for taking out logs became a powerful torrent in a very short time.

Slika 13: Sledovi močne globinske erozije v Hudem grabnu (ime!) nad Golnikom. Skoraj v smeri največjega strmca potekajoča gozdna vlaka, ki je nekdaj služila predvsem za spravilo lesa, se je v zelo kratkem času spremenila v mogočen hudournik.

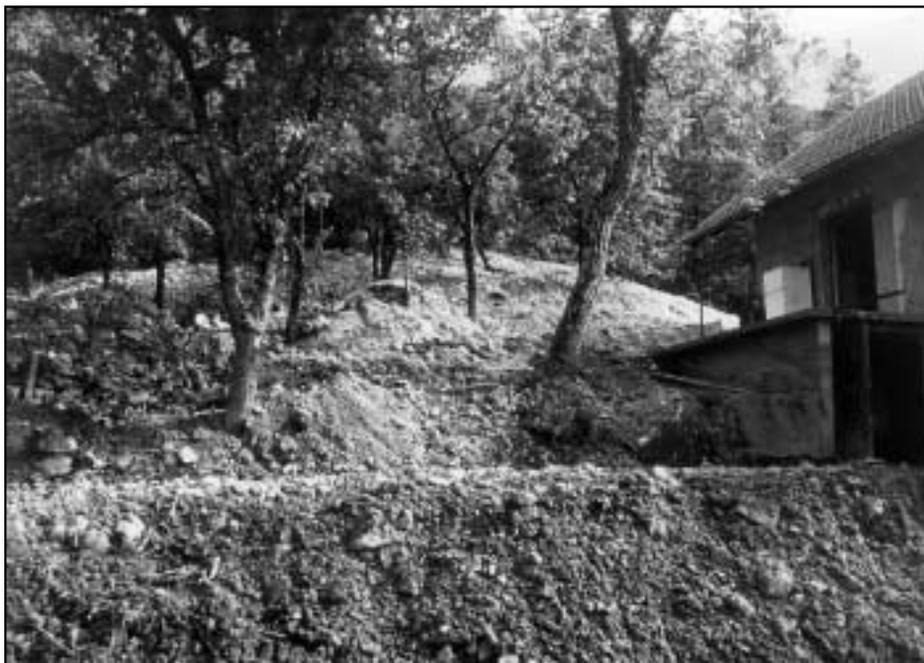
Figure 15: Alluvial fan at the outlet of the torrential Hudi graben in the orchard above a house on the upper edge of the settlement.
Slika 15: Akumulacijski vršaj ob izteku hudourniškega Hudega grabna v sadovnjaku nad hišo na zgornjem robu naselja.

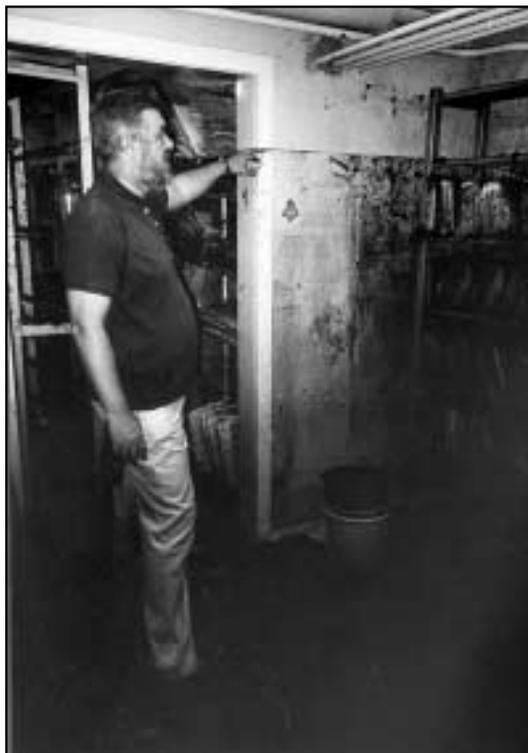
Figure 17: Height of water level in the hospital basement and shelves with ruined archive materials.
Slika 17: Višina vode v kletnih prostorih bolnišnice in police z uničenim arhivskim gradivom.

- the site of the settlement at the transition from the steep permeable area to a gentler impermeable area (marl, sandstone) accelerated and strengthened the power of torrential water;
- some new houses were built on unsuitable locations at the outlets of still used and abandoned forest tracks;
- an unfavourable combination of relief and construction components caused irreparable damage at the hospital with the permanent destruction of archive records (Figure 17).

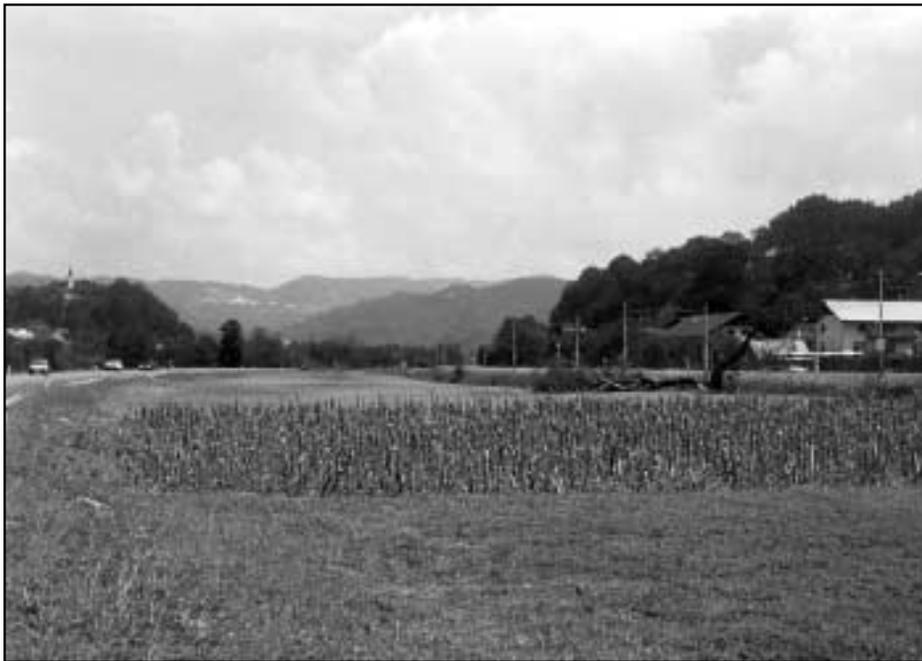
Figure 18: Felled trees and agricultural surfaces completely destroyed by hail near Litija. Hail damaged only a narrow belt of the total area struck by the storm.

Slika 18: Podrta drevesa in po toči povsem uničene kmetijske površine pri Litiji. Toča je prizadela le ožji pas v neurju prizadetega površja.

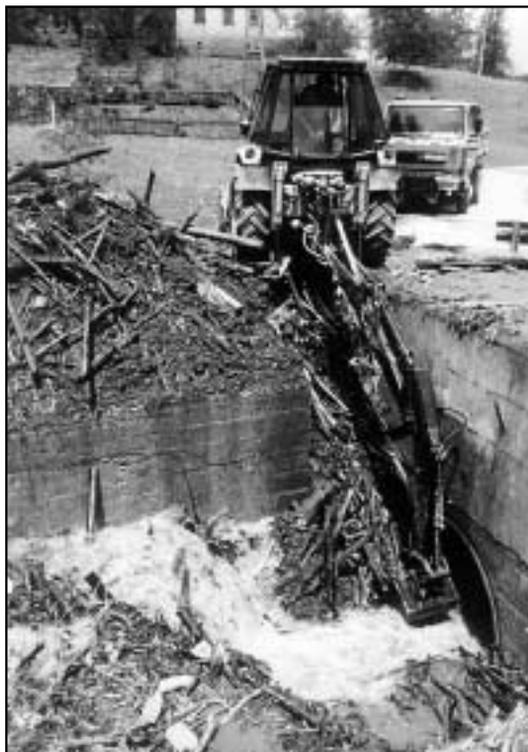
Figure 19: Clearing an outlet in one of the numerous ravines in the surroundings of Litija. Torrential waters mainly carried wood debris among which there was considerable amounts of garbage from uncontrolled refuse dumps along the stream.

Slika 19: Čiščenje prepusta na enem od številnih grabnov v okolici Litije. Hudourniške vode so prinesle predvsem lesno plavje med katerim je bilo tudi veliko odpadkov z divjih odlagališč ob potoku.

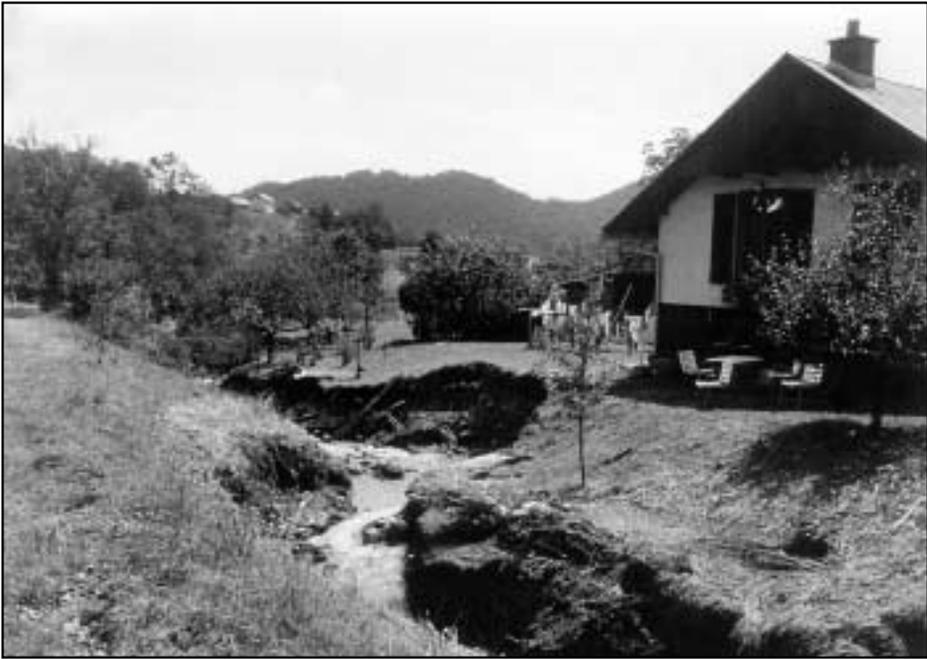
Figure 20: The riverbed of a smaller stream widened and deepened by erosion threatened a house near Litija. How deep the side erosion will be the next time a storm occurs and whether the house will then be far enough from the stream are questions we must answer in dealing with the issue of natural disasters as a whole.

Slika 20: Erozijsko razširjena in poglobljena struga manjšega potoka blizu Litije je ogrozila eno od tamkajšnjih stanovanjskih hiš. Kako globoke bodo bočne zajede prihodnjic, kdaj bo to in ali bo takrat hiša še dovolj odmaknjena od potoka so le ena izmed vprašanj, na katere bomo morali odgovoriti tudi s celostnejšim obravnavanjem problematike naravnih nesreč.
