THE 1994 SUMMER STORM IN THE BOLSKA RIVER WATERSHED (CENTRAL PART OF EASTERN SLOVENIA)

Milan Natek

The 1994 Summer Storm in the Bolska River Watershed (Central Part of Eastern Slovenia)

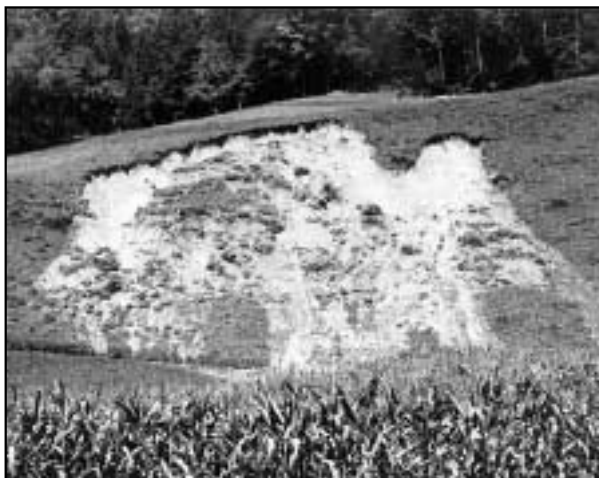
A typical small landslide in the Bolška river watershed
(photography M. Natek).

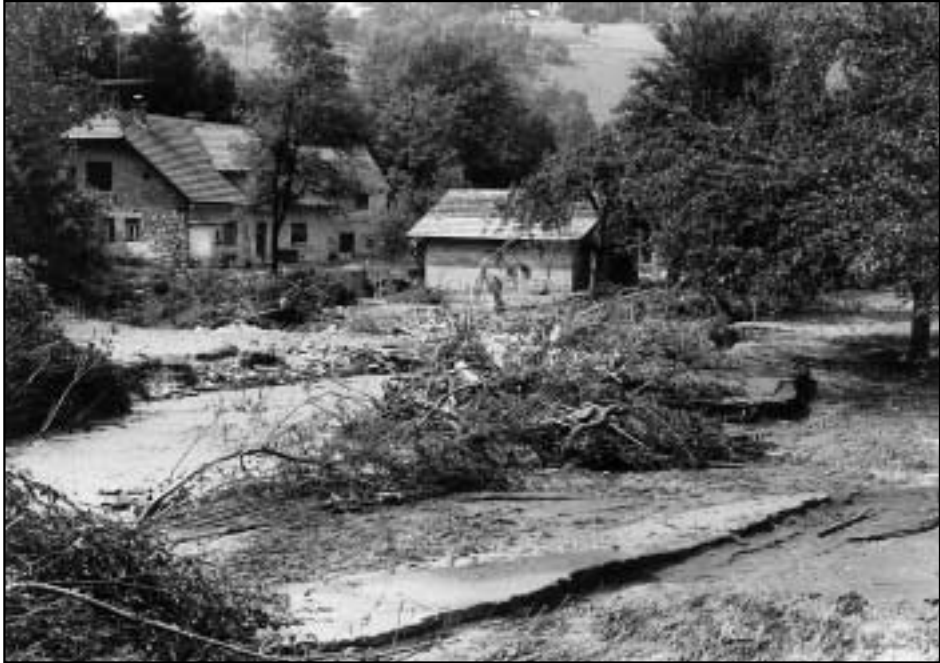
Figure 2: Until now, most of the homes in Loke were safe from floods, but the June inundation did not spare them. Flood debris on the site of one of the flooded homes.

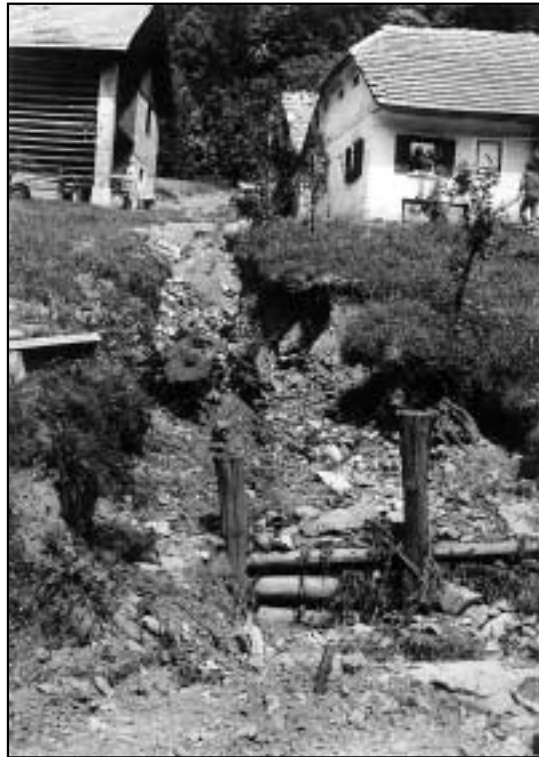
Figure 3: Water carried copious amounts of rough material to the Zaplaninščica Valley along an erosion gully running from below Kozica (978 m). This material clogged the plain and slowed the rapid flow of the swollen Zaplaninščica. The Kovač family, whose home is located on a fan, employed primitive measures to reduce the destructive effects of the torrent.

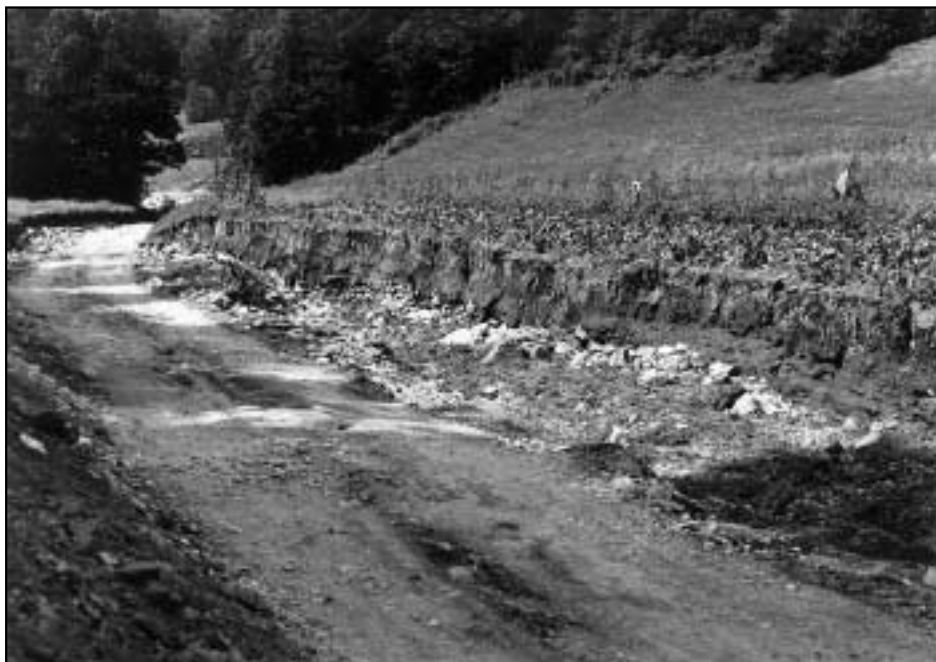
Figure 4: The June storm completely cut the road to Zaplanina. Near the Kovač home the Zaplaninščica dug itself a new riverbed in the asphalt road surface and filled the old one with alluvium. It carried away a section of a field belonging to Kovač measuring 80 to 100 m in length and 3 to 6 m in width.

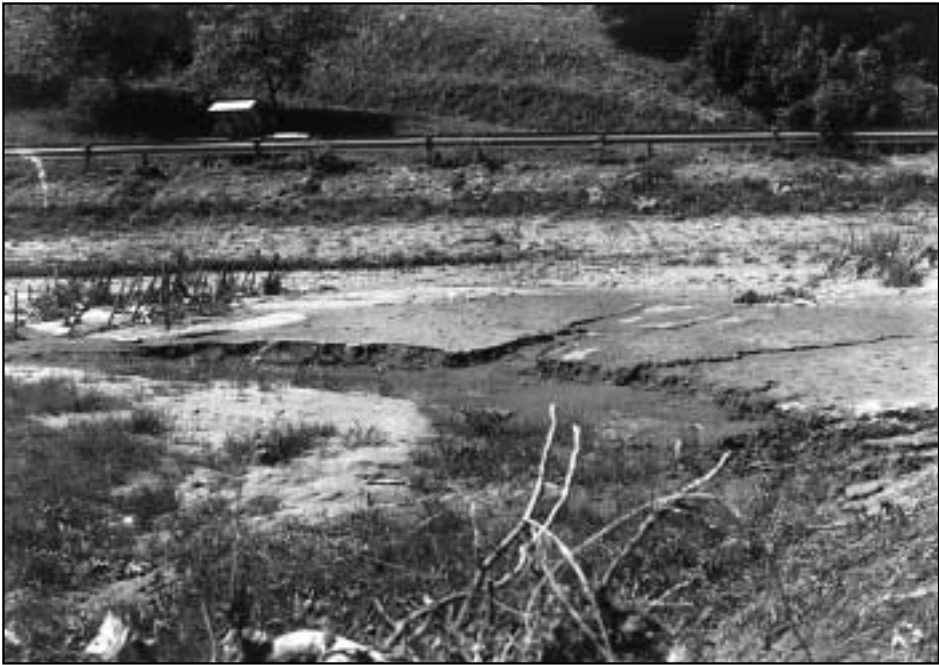
Figure 5: There is a large confluence at Ločica where the Bolska is joined by the Zaplaninščica, Smečka, Kotnica, and Motnišnica rivers. During the last five years, inundation has regularly affected the area between the mouth of the Zaplaninščica and the Smečka. The June inundation left visible marks in the area: the stone, sand, and mud alluvium, which was as thick as 55 cm in places, destroyed the crops.

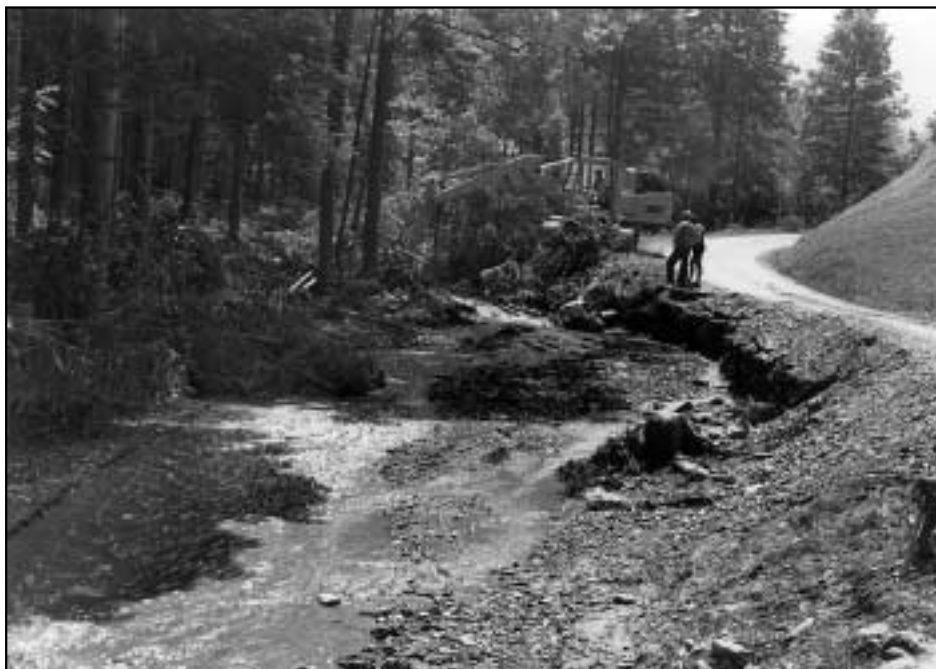
Figure 6: The Zaplaninščica just above its mouth on the Bolska near Ločica. The riverbed that had been clogged with alluvium and presented a threat to the road to Zaplanina was cleared with a dredger.

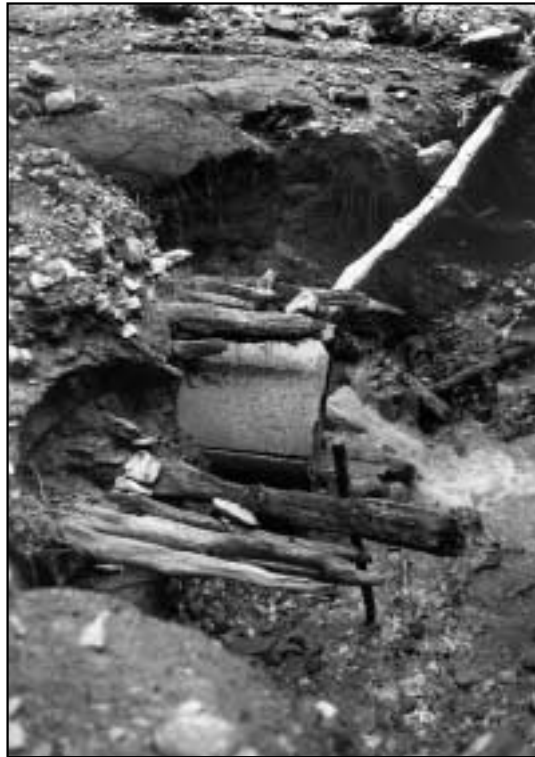
Figure 7: The remains of a »bridge« to Vrhovec (Črni Vrh) in the catchment area of the Kučnica. Erosion deepened the riverbed of the Ravljanski stream by more than a meter, widening it at the same time and washing away the cart track connecting the farm with valley.

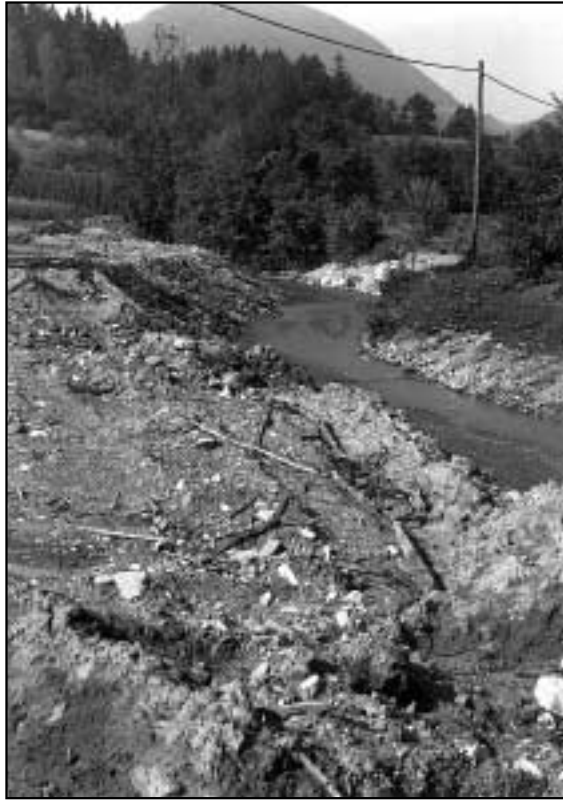
Figure 8: The inundation left behind real devastation. The cleared Konjščica riverbed between Tabor and Loke is once again performing its previous function.

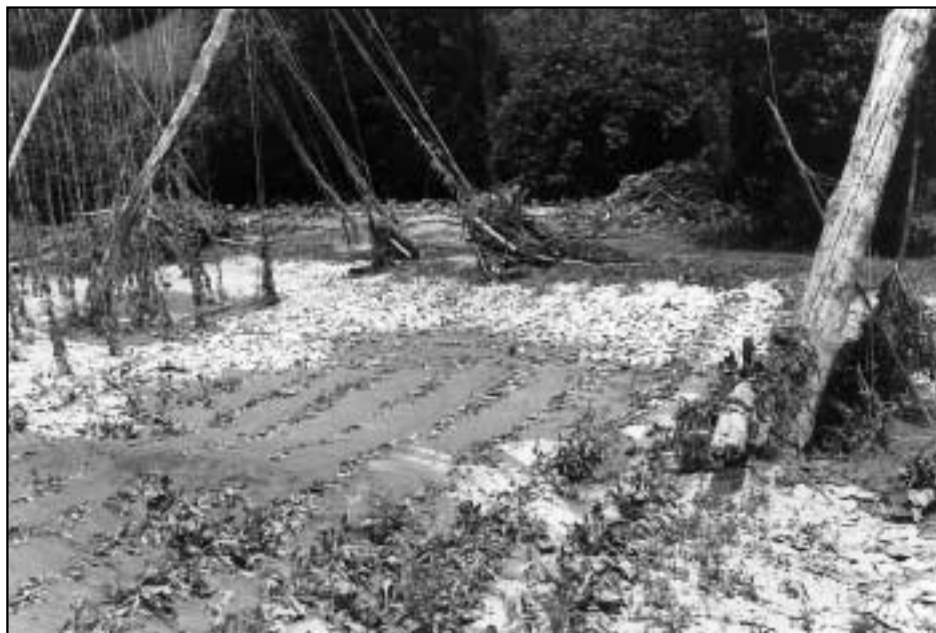
Figure 9: With its rapid current, the inundation destroyed a bean plantation in a former hop field (Loke).
Slika 9: Povodenj je s svojim deročim tokom uničila tudi fižolov nasad v nekdanjem hmeljišču (Loke)

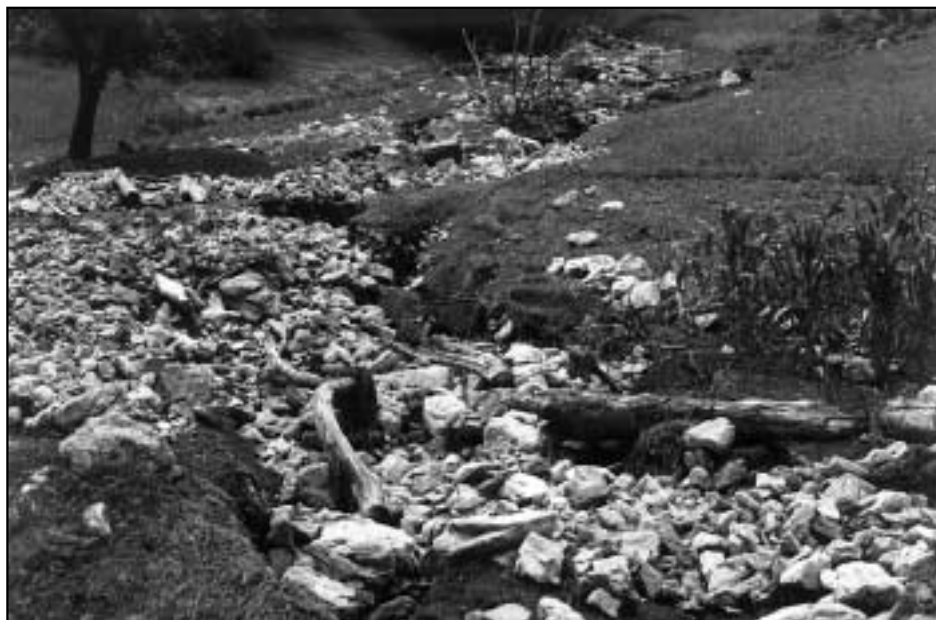
Figure 10: The Sušica, which is normally only filled during rain, deposited stones and gravel on Erjavce's meadow. The meadow surface was furrowed by numerous erosion ditches and gullies (Črni Vrh).
Slika 10: Sušica, ki jo napolni samo deževnica, je odložila na Erjavčev travnik kamenje in drobir. Travniško površino pa je razbrzdala s številnimi erozijskimi jarki in žlebovi (Črni Vrh).

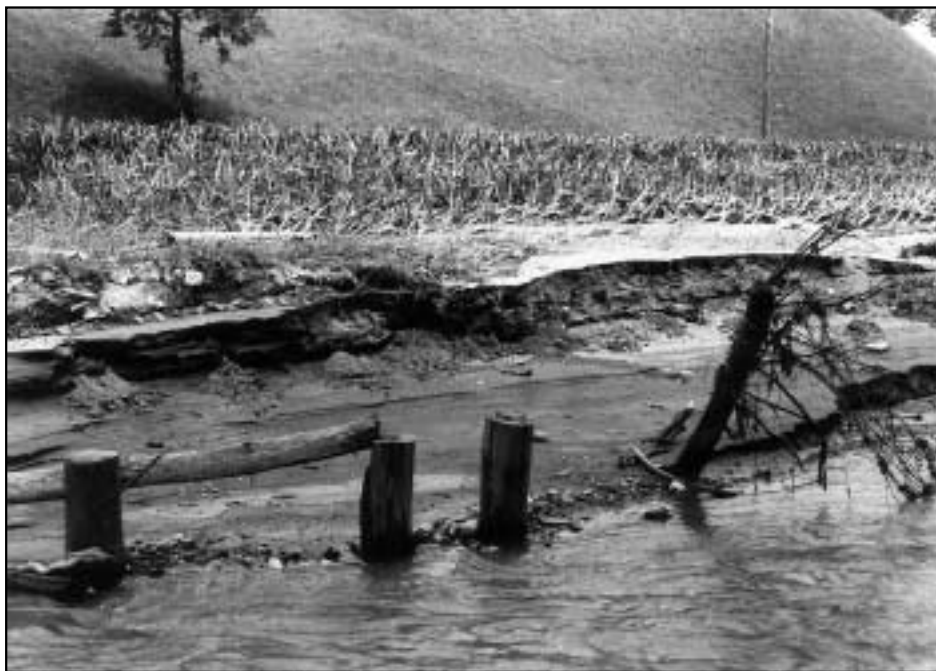
Figure 11: At Loke only a few pilings remained of the village bridge that connected the fields on either side of the torrential Konjščica. In this area, too, the stream »uncontrollably« widened its riverbed and damaged agricultural land.

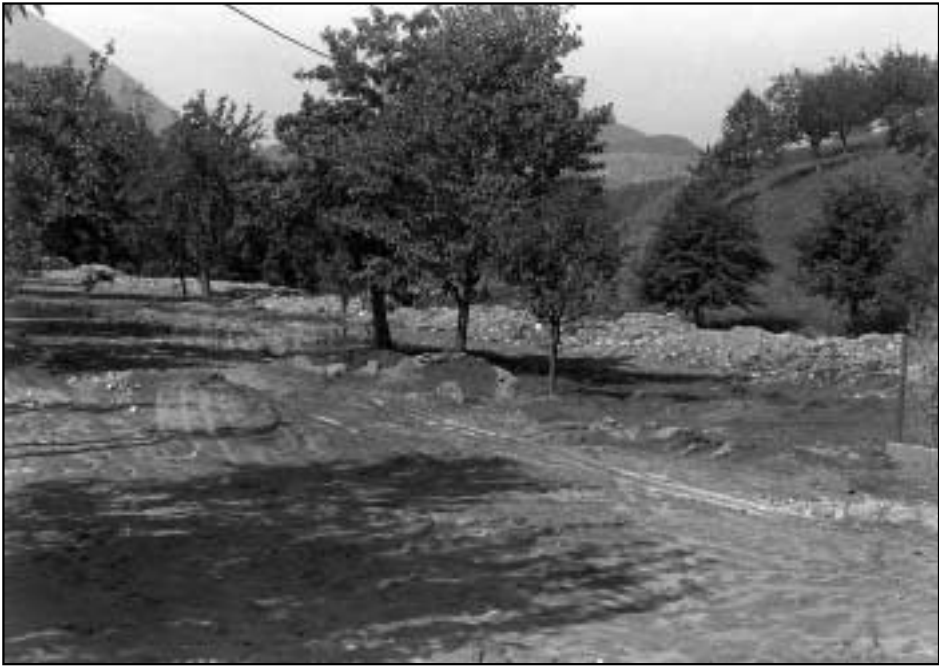
Figure 12: The swollen Konjščica covered the Ropret orchard in Loke with a thick layer of flood material (20 to 55 cm), which was removed soon after the inundation.

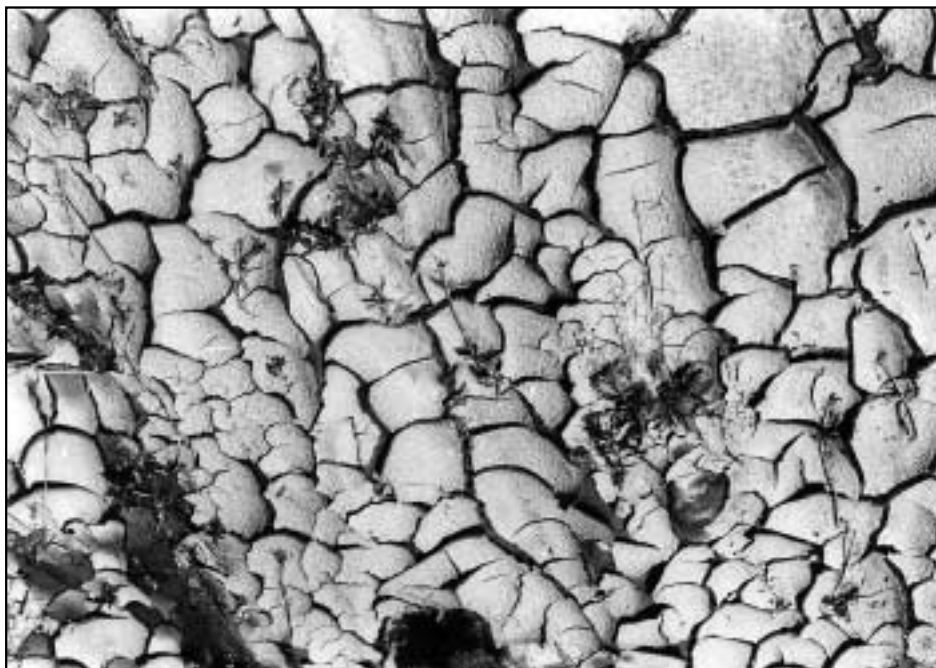
Figure 13: Dried mud as the remains of flood material. The farmers removed most of the mud deposits from their fields and meadows.
Slika 13: Izsušeno blato kot ostanek poplavne naplavine. Večino blatnega nanosa so kmetje odstranili s svojih polj in travnikov.

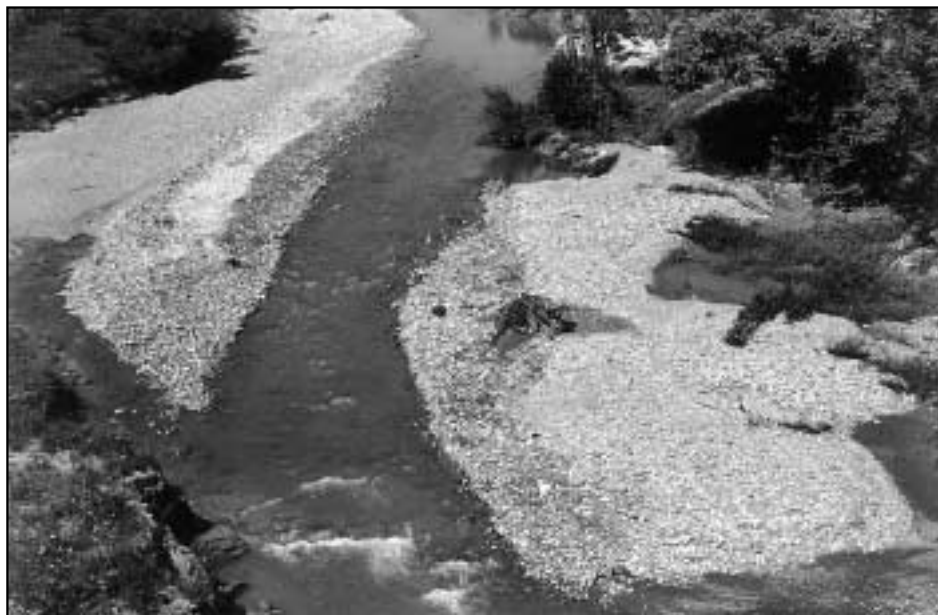
Figure 14: The Bolska River near Vransko. Every year storms and inundation wreak havoc to the Bolska riverbed. From year to year, larger gravel deposits form at Brode where the river turns northward in a sharp bend.

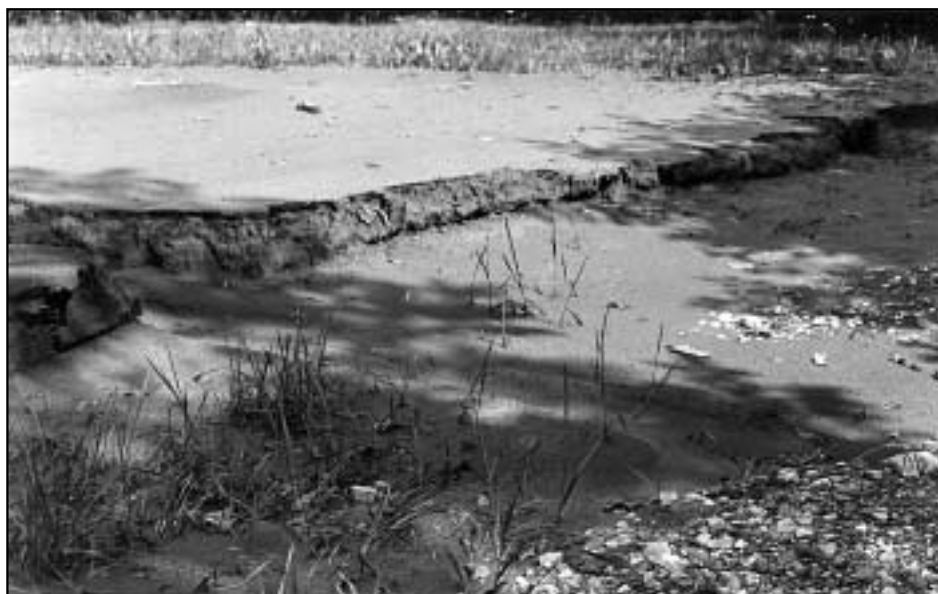
Figure 15: The meadows along the Konjščica were devastated by sand and clay flood material. A view of a layer of flood material, 30 to 50 cm thick, deposited south of Loke settlement.

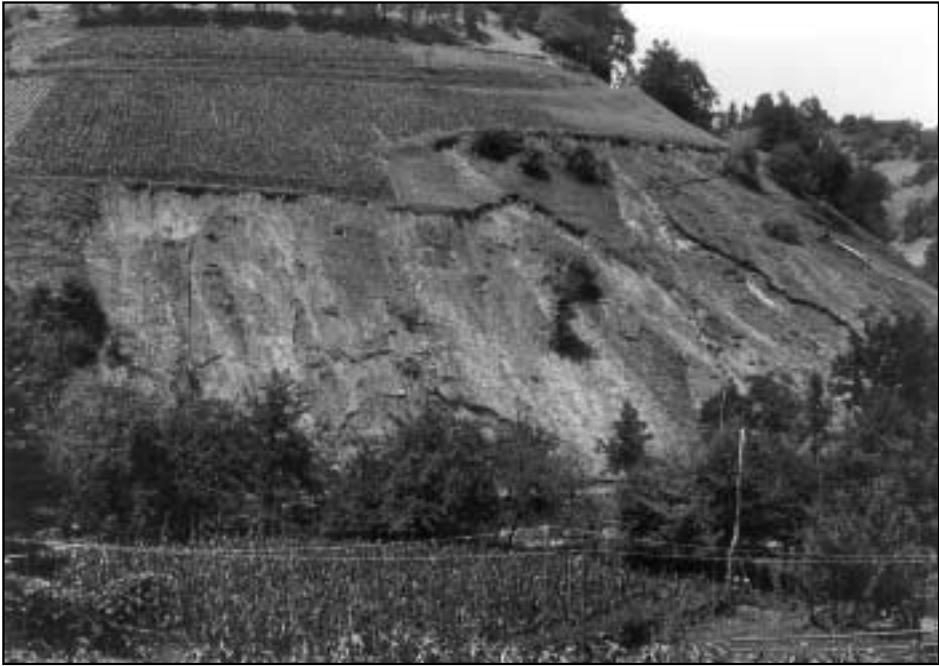
Figure 16: The lower slopes of the Križnik farm (Ojstrica below Črni Vrh) were furrowed and left bare by numerous landslides.
 Slika 16: Spodnja pobočja Križnikovega hriba (Ojstrica pod Črnim Vrhom) so razoralo in ogolili številni zemeljski plazovi in usadi.

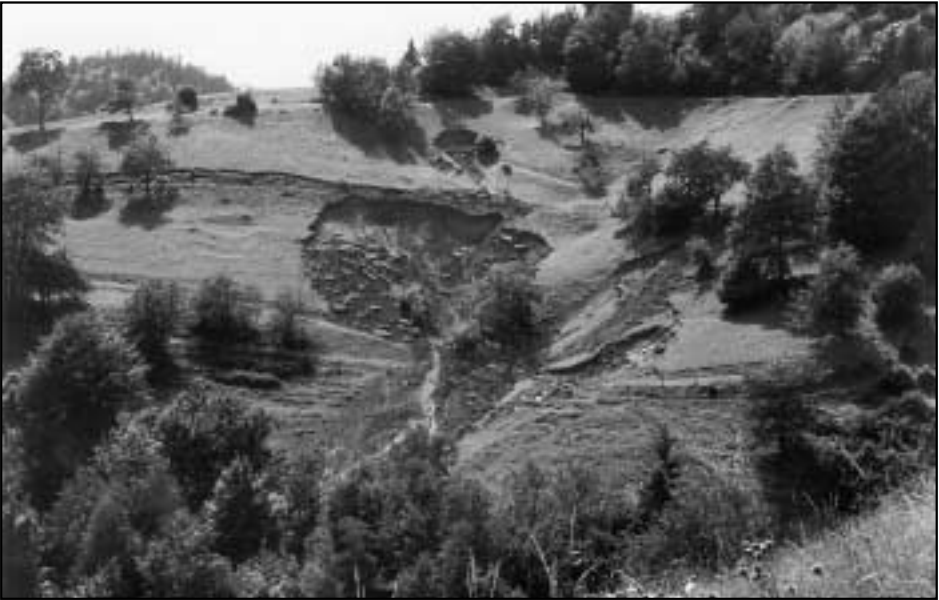
Figure 17: The grassy slopes of the Jerman farm in Dol (Črni Vrh) situated at the left bank of the Kučnica were torn up by landslides.
Slika 17: Travnata pobočja Jermanove domačije v Dolu (Črni Vrh), ki je na levem bregu Kučnice, so razrili zemeljski plazovi.

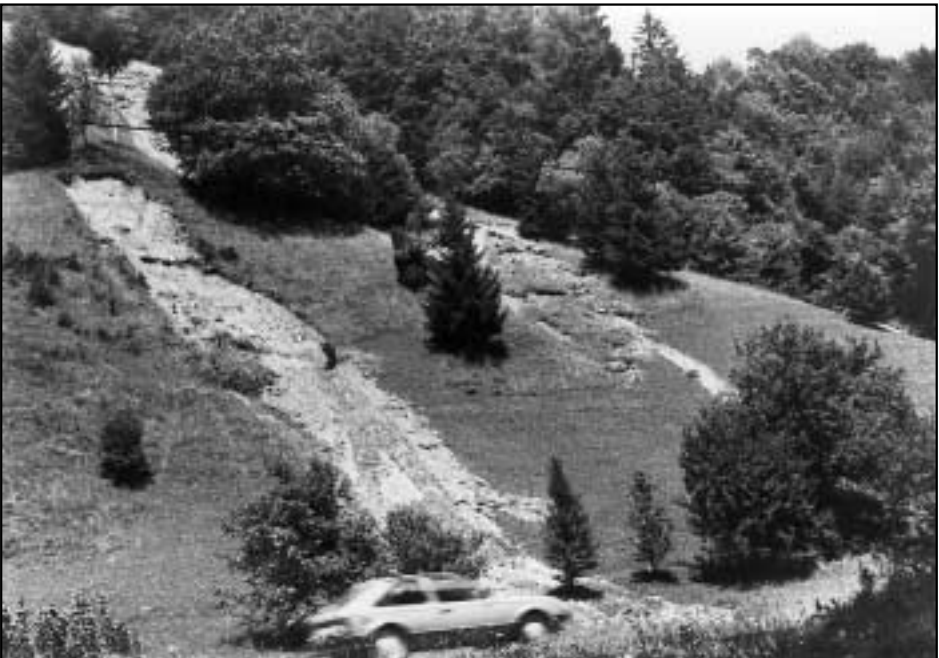
Figure 18: The southeastern slopes of Jasovnik (765 m) belonging to the farming hamlet of Osredek (Ločica), was newly divided by more than 25 landslides. Slide material also covered the Ljubljana–Celje highway.
Slika 18: Jugovzhodno pobočje Jasovnika (765 m), ki pripada kmetijam zaselka Osredek (naselje Ločica pri Vranskem), je na novo razčlenilo več kot 25 plazov, usadov in posedov. Plazovina je zasula tudi cesto Ljubljana–Celje.

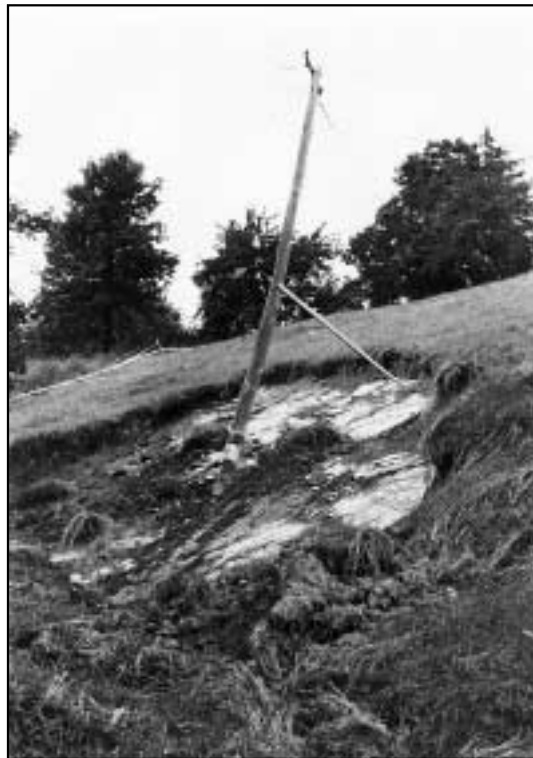
Figure 19: Landslides damaged or destroyed electrical, telephone, and water networks. The photograph is from Črni Vrh.
Slika 19: Zemeljski plazovi in usadi so poškodovali in uničili tudi električno, telefonsko in vodovodno omrežje. Posnetek je iz Črnega Vrha.

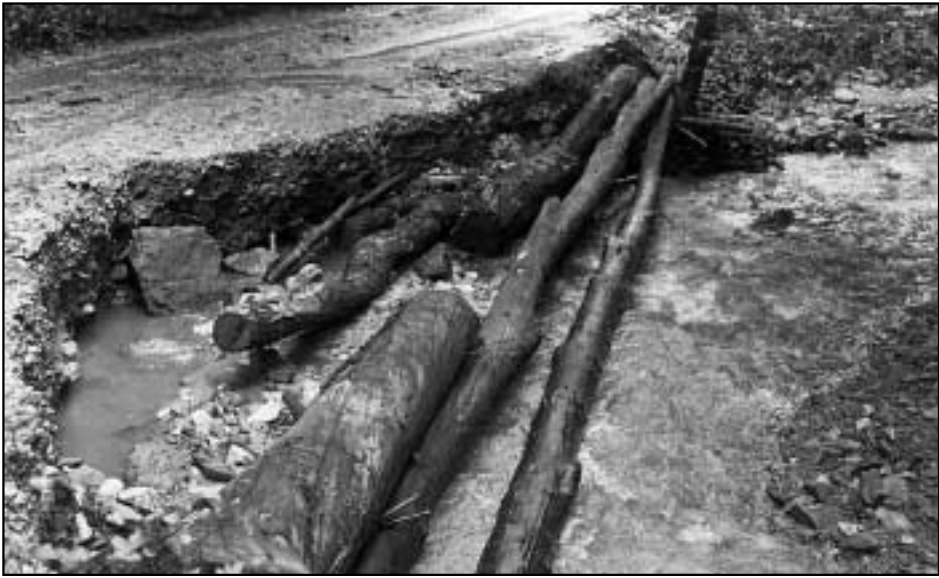
Figure 21: In its catchment area, the Reka (Marija Reka near Prebold) undercut its banks and damaged and washed away the road. Local residents used primitive means to protect the banks from further destruction.

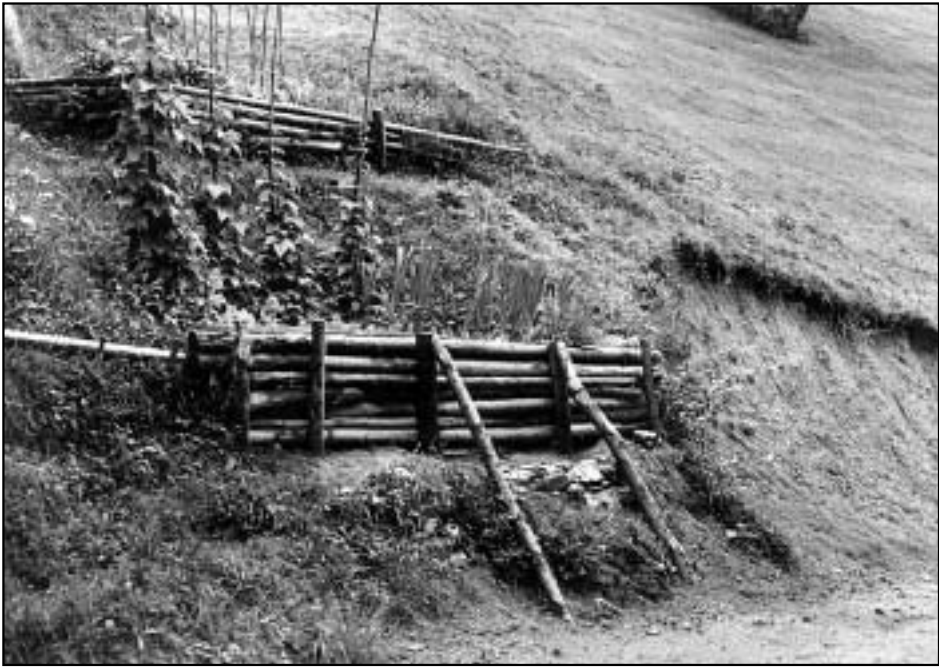
Figure 22: By erecting simple »scarp« with wooden supports, the owner of a vacation cottage in Marija Reka protected his garden from the sliding slope material which is abundant on the southern slope of Reška planina (925 m).
